1. Introduction

A detailed assessment of the fuel load and potential for future releases was conducted for the sunken Second World War-era vessel, USS *Chehalis*, Pago Pago Harbor, Tutuila Island, American Samoa. As discussed in detail in the report for previous work phases (Phase I & II, CH2M Hill 2006) the vessel was a gasoline carrier that caught fire and sank approximately 350 feet north of the fuel dock in Pago Pago Inner Harbor on 07 October 1949. Work previous to this Phase III investigation included a review of available archival information relevant to ship's structure and operations (Phase I), a pre-dive survey using a submersible remotely controlled vehicle (ROV) (Phase I), an external "stand off" visual survey by divers (Phase II), and limited sediment and water sampling in the vicinity of the vessel for analysis for petroleum hydrocarbons (Phase II). This report documents the results of Phase III of the *Chehalis* investigations. Phase III was designed and implemented based on findings from previous phases of the work. Phase III follows on the probability raised by the results of Phase I & II that indicate a significant quantity of fuel remains on-board the vessel.

T

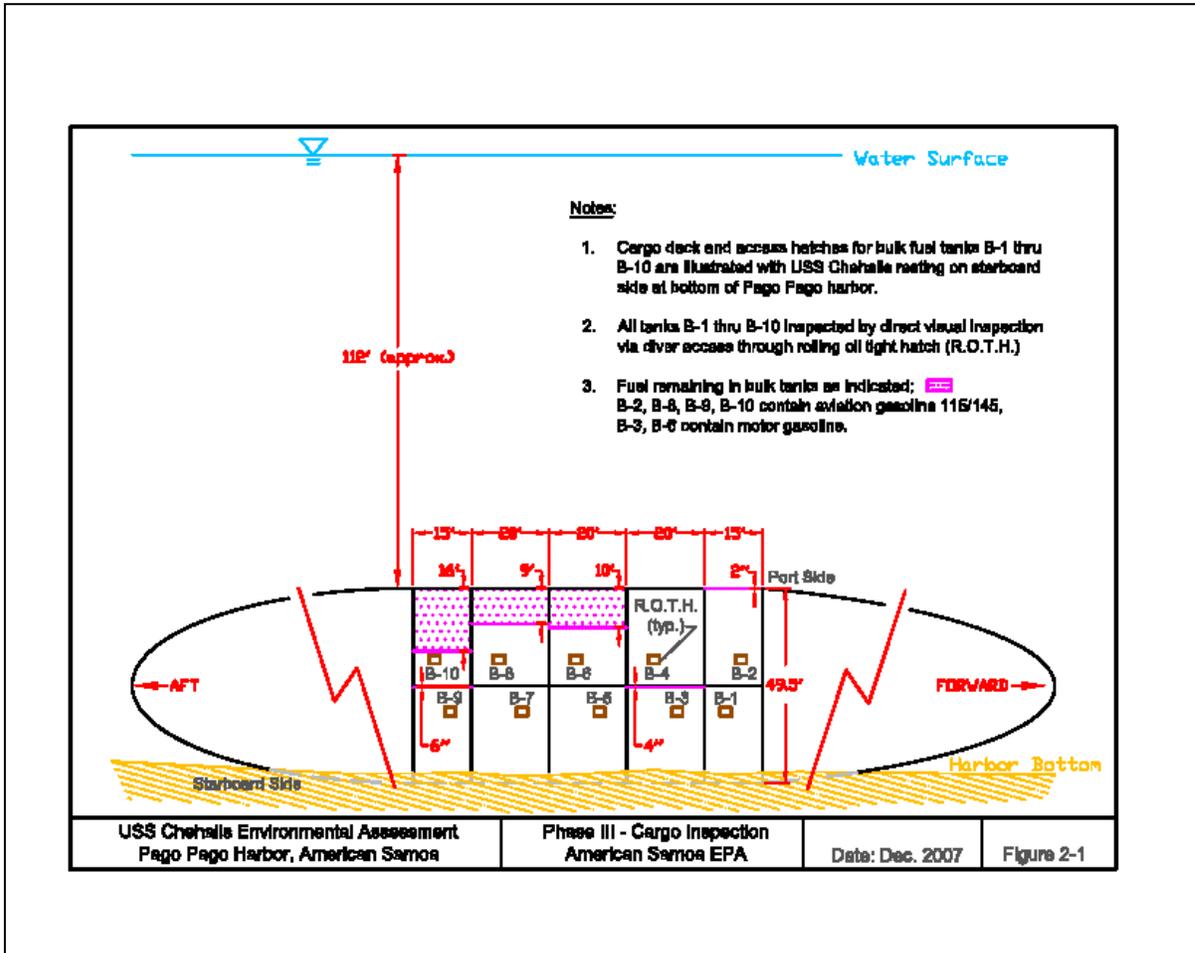
Figure 2-1: Fuel remaining in cargo tanks B-1 thru B-10

Aviation gasoline (115/145) and motor gasoline fuel was found in cargo tanks B-2, B-3, B-6, B-8, B-9 and B-10 (see Figure 2-1). Diesel fuel was found in ship's aft fuel tank C-905 (see Figure 2-2). Direct visual inspection, application of flame-test, and laboratory analytical results, confirm fuel types (Figures 2-3 and 2-4, and Appendix D).
