AMERICAN SAMOA WATERSHED PROTECTION PLAN

Volume 4: Stormwater Management Evaluations

**Nuuuli Watershed
Daniel Inouye Industrial Park
Pago Pago Watershed
Vatia Watershed
Tula Watershed
Leone Watershed**

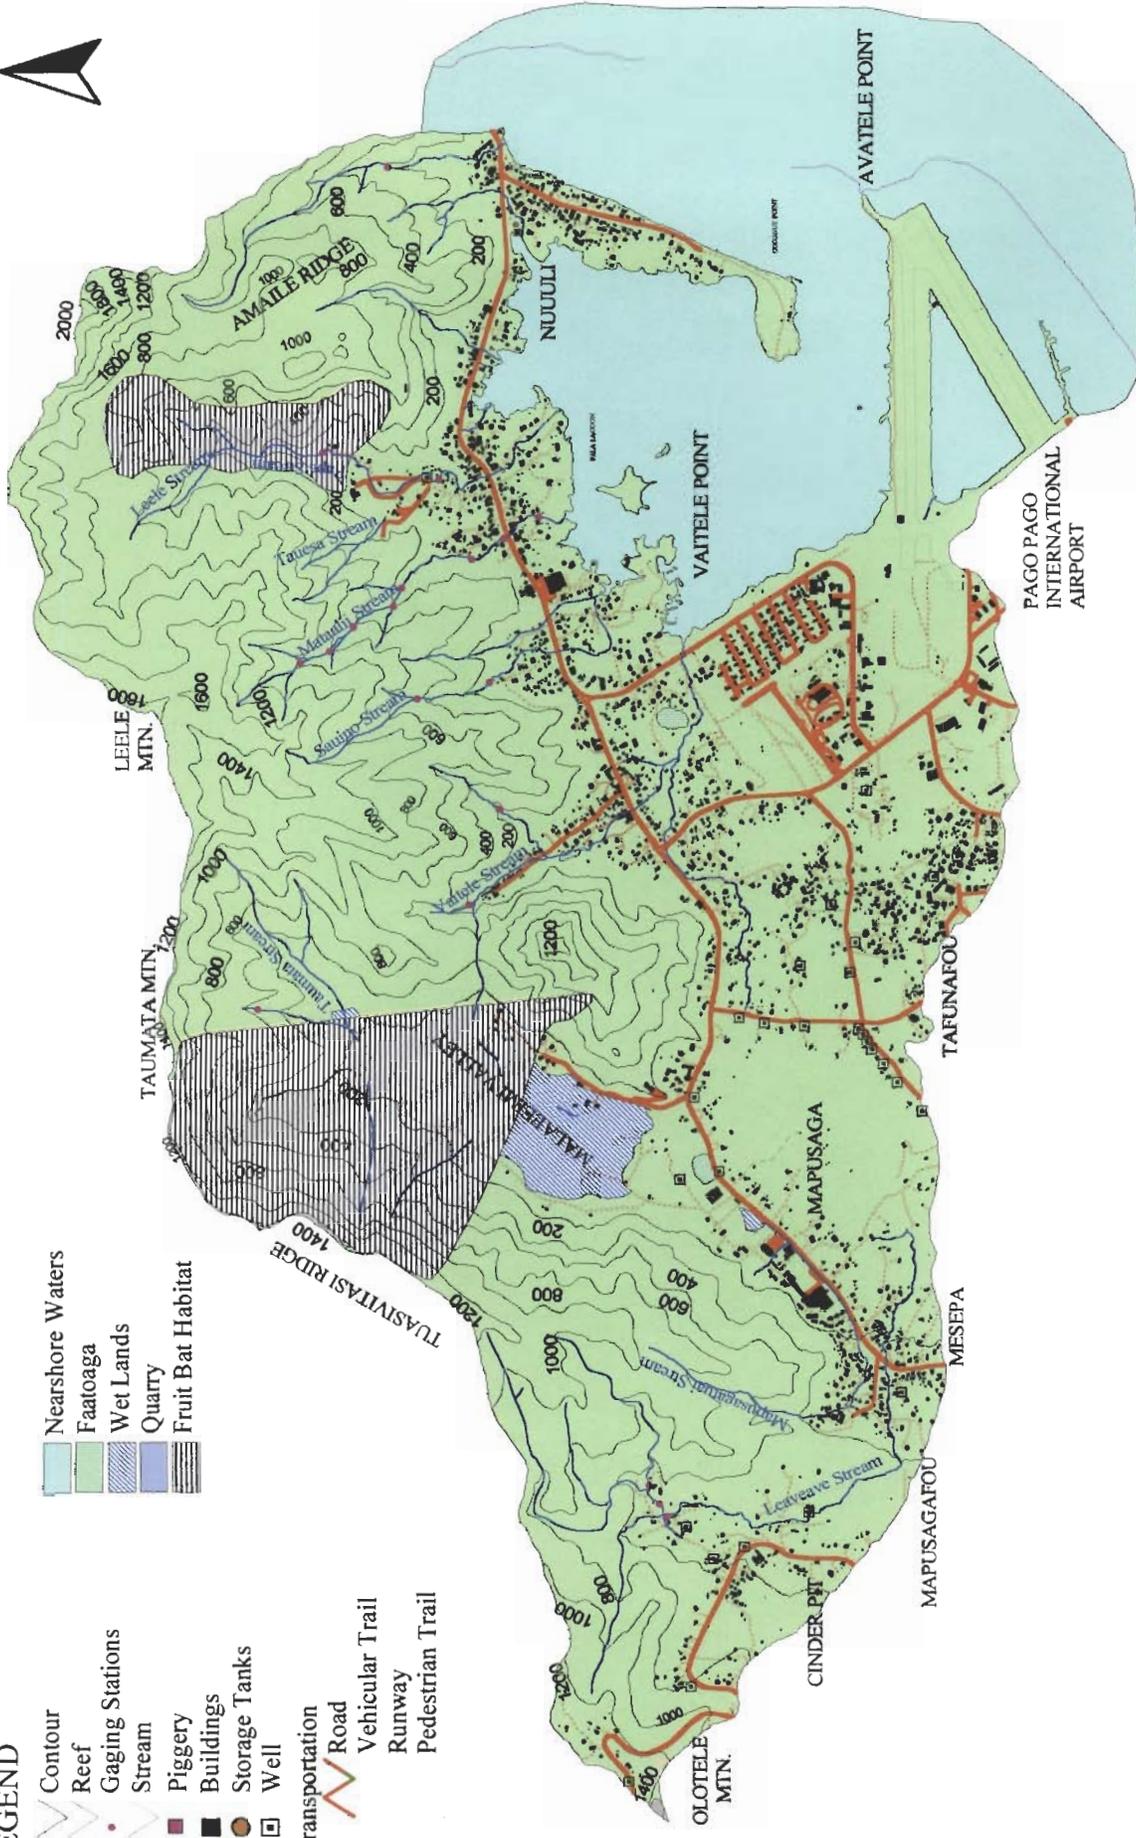
Nuuuli Pala Watershed

Existing Conditions

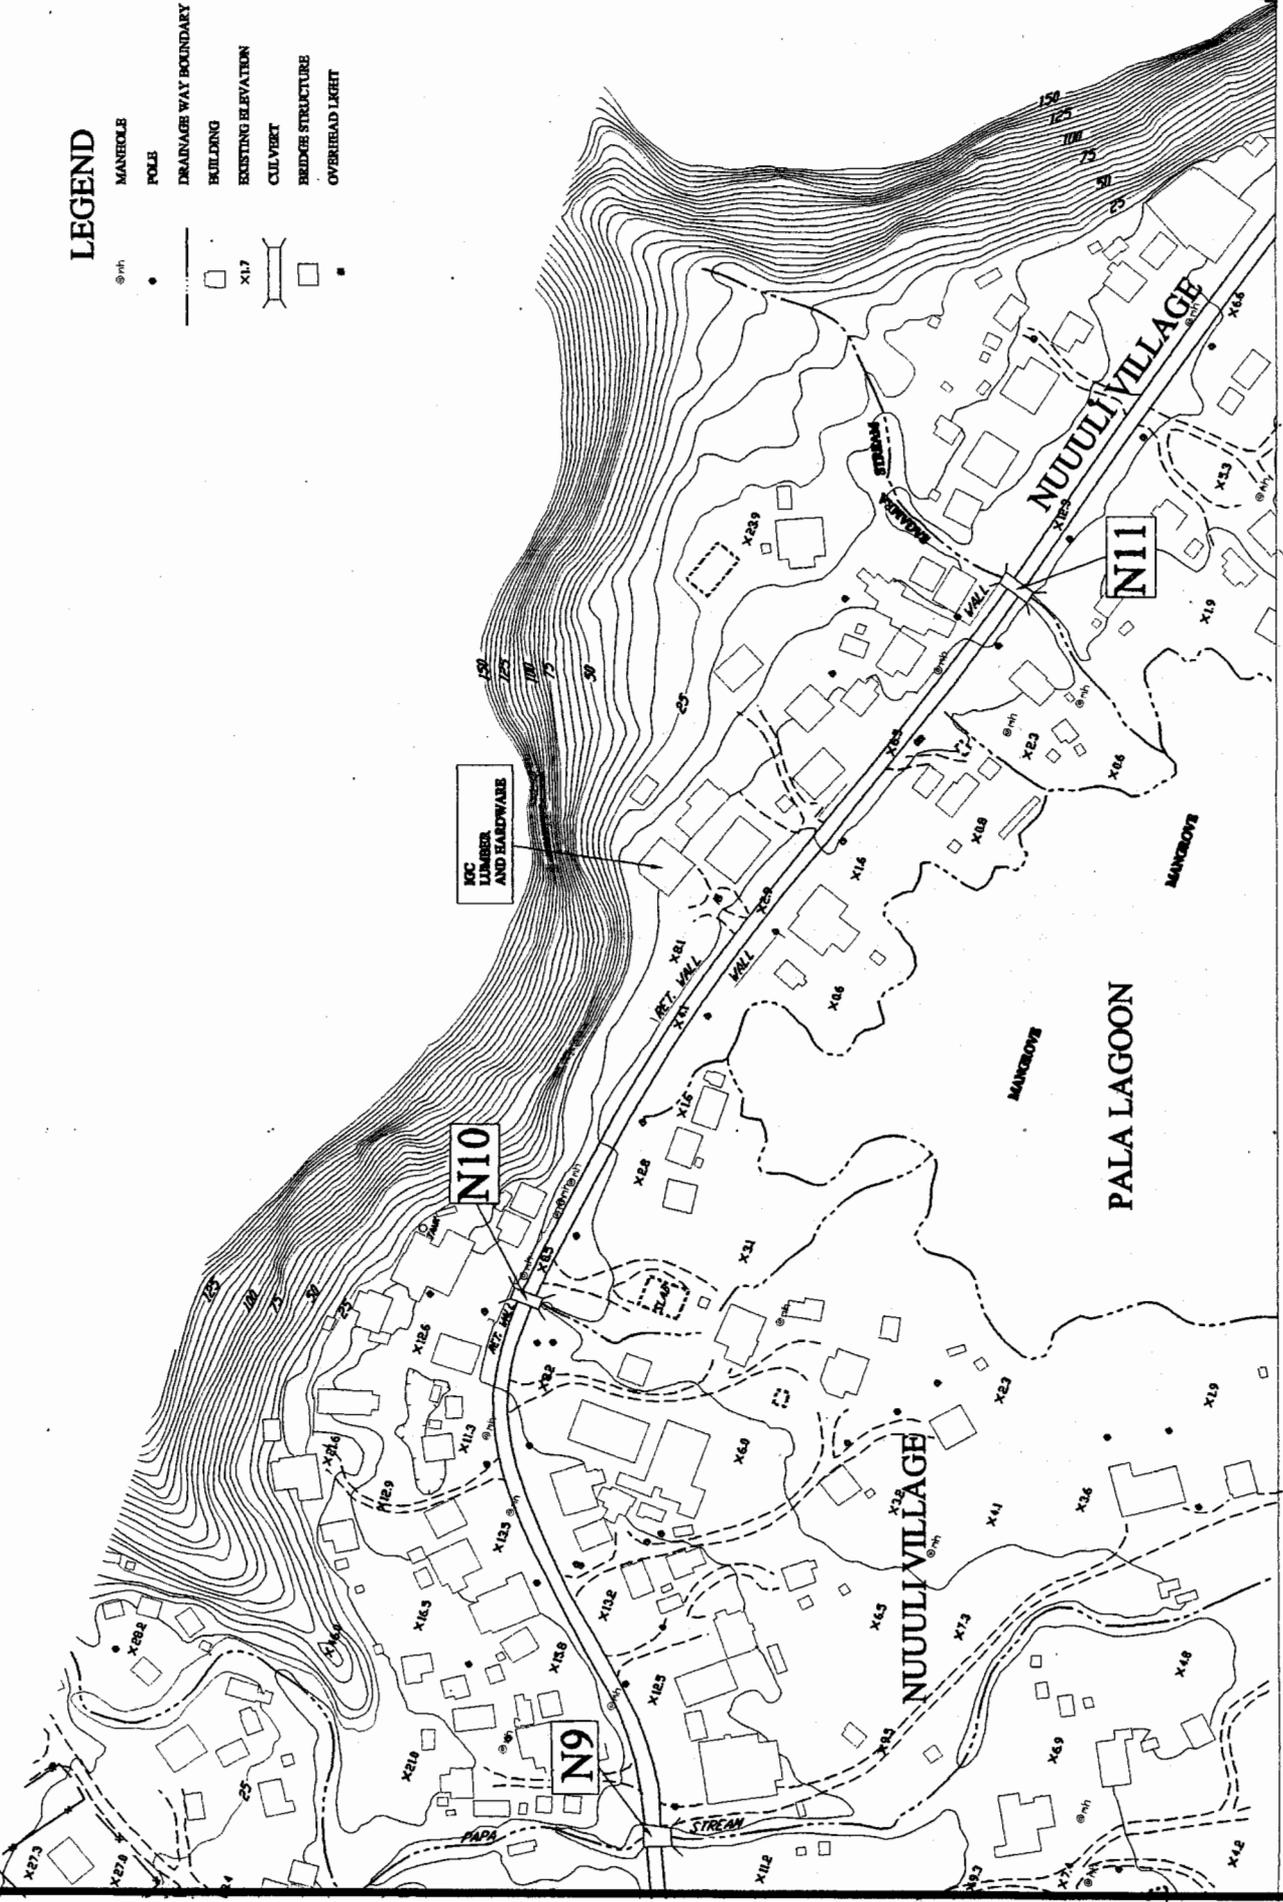
Figure 2-4

**NUULI STORMWATER MANAGEMENT FACILITIES
ALONG PRIMARY SHORELINE ROADWAY**

A field survey of the 13 culverts in May, 1998 revealed that existing culverts are generally in good structural condition. The physical deficiencies associated with each culvert are summarized in Table 2-6; culvert locations are presented in Figures 2-2 through 2-5.

It is recommended that proposed improvements to stormwater culverts along the primary shoreline roadway, between Vaitele Stream and Amaile Stream, be constructed (Table 2-6). Some of the culverts are also somewhat undersized to accommodate higher stormwater flows. The addition of a second box culvert would permit, in some cases, the passage of greater stormwater flows underneath the primary shoreline roadway. The construction of additional culverts in some locations (Table 2-6) will increase facility capacity and reduce future flood potential along the primary shoreline roadway. However, in other locations, the bank outlet is narrower than the width of the existing culvert outlet.

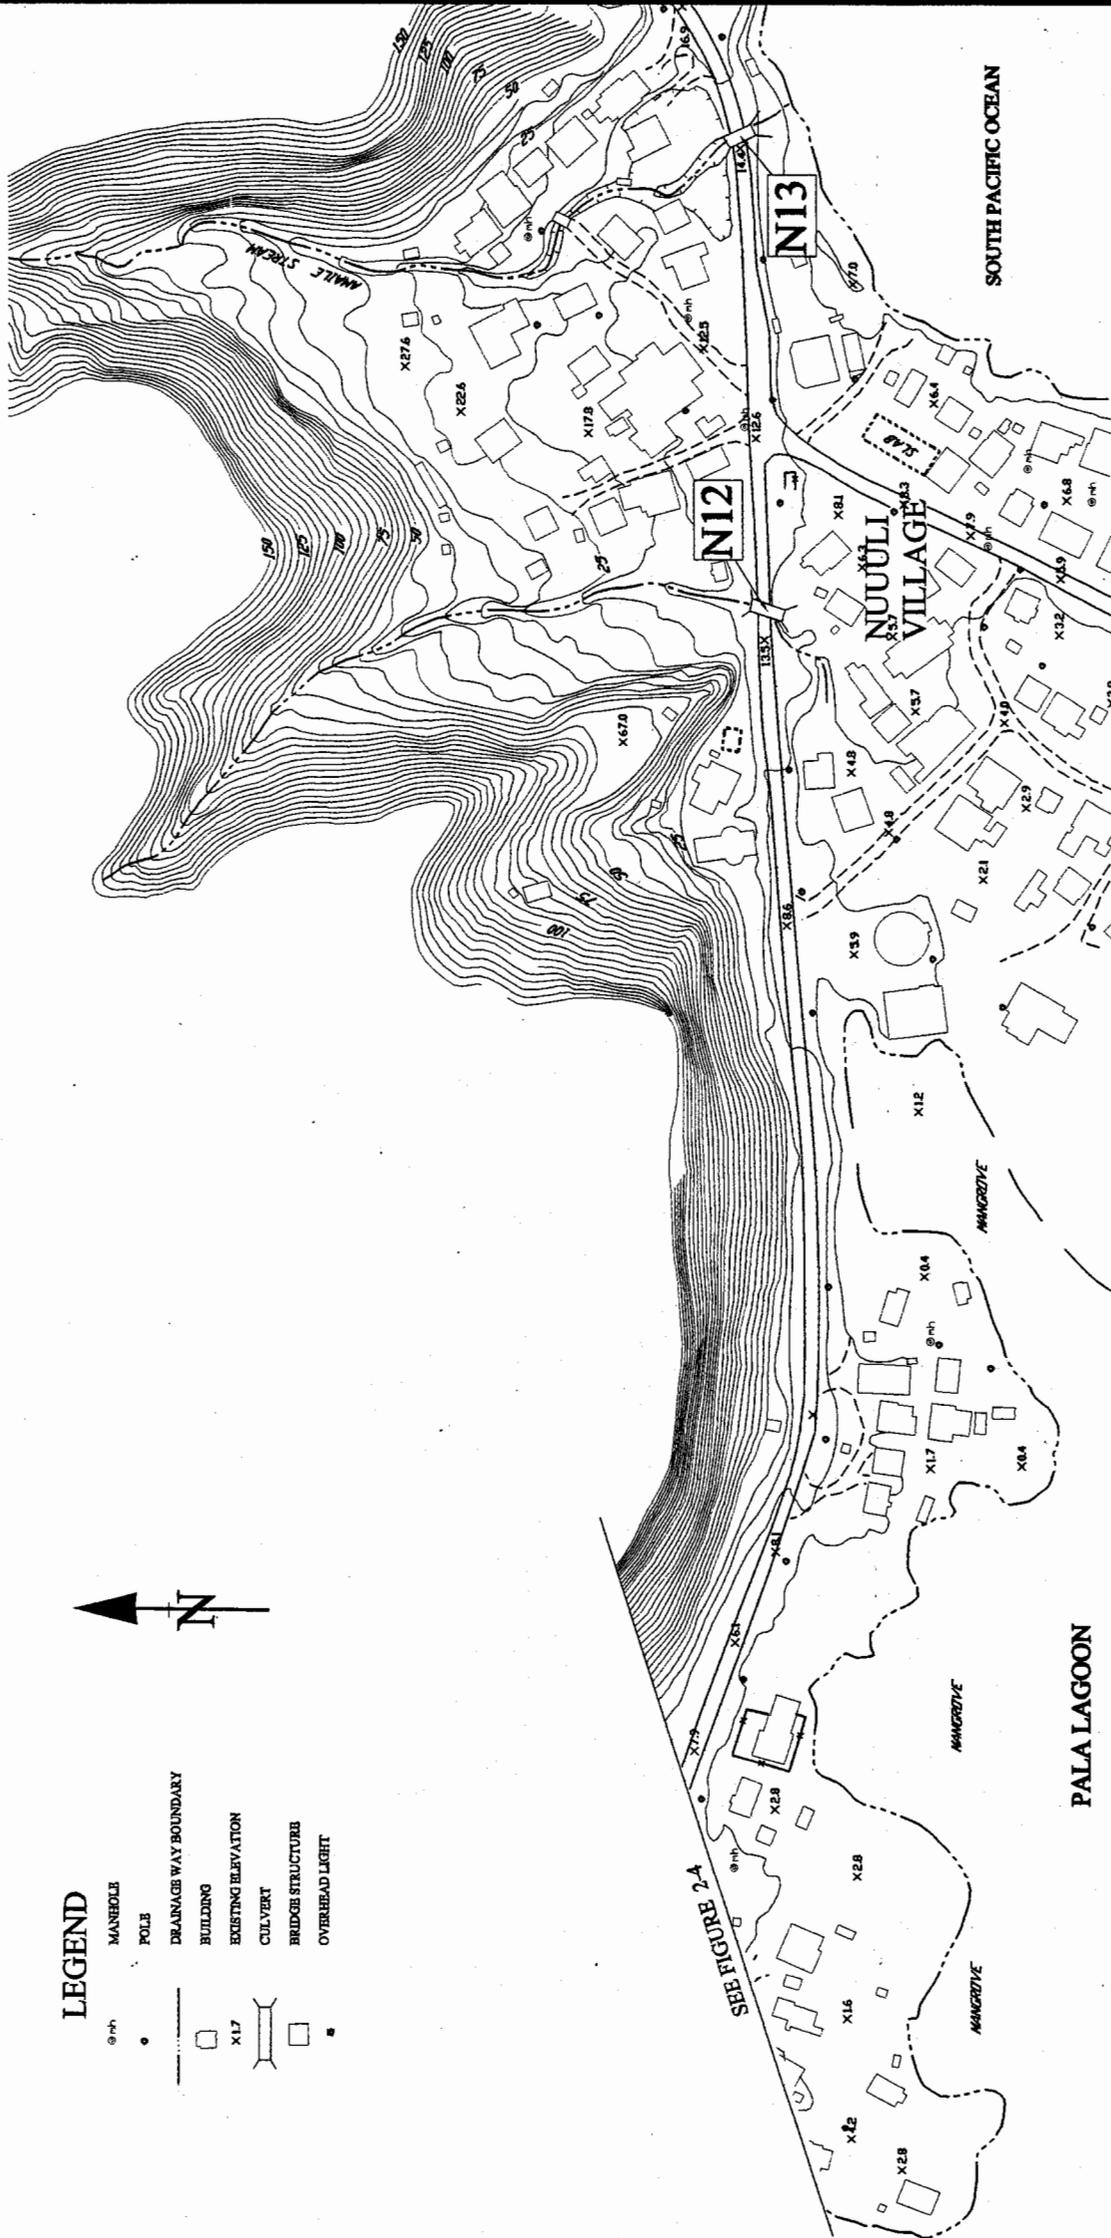
**NUUULI STORMWATER MANAGEMENT FACILITIES
ALONG PRIMARY SHORELINE ROADWAY**
Scale: NOT TO SCALE Figure 2-5

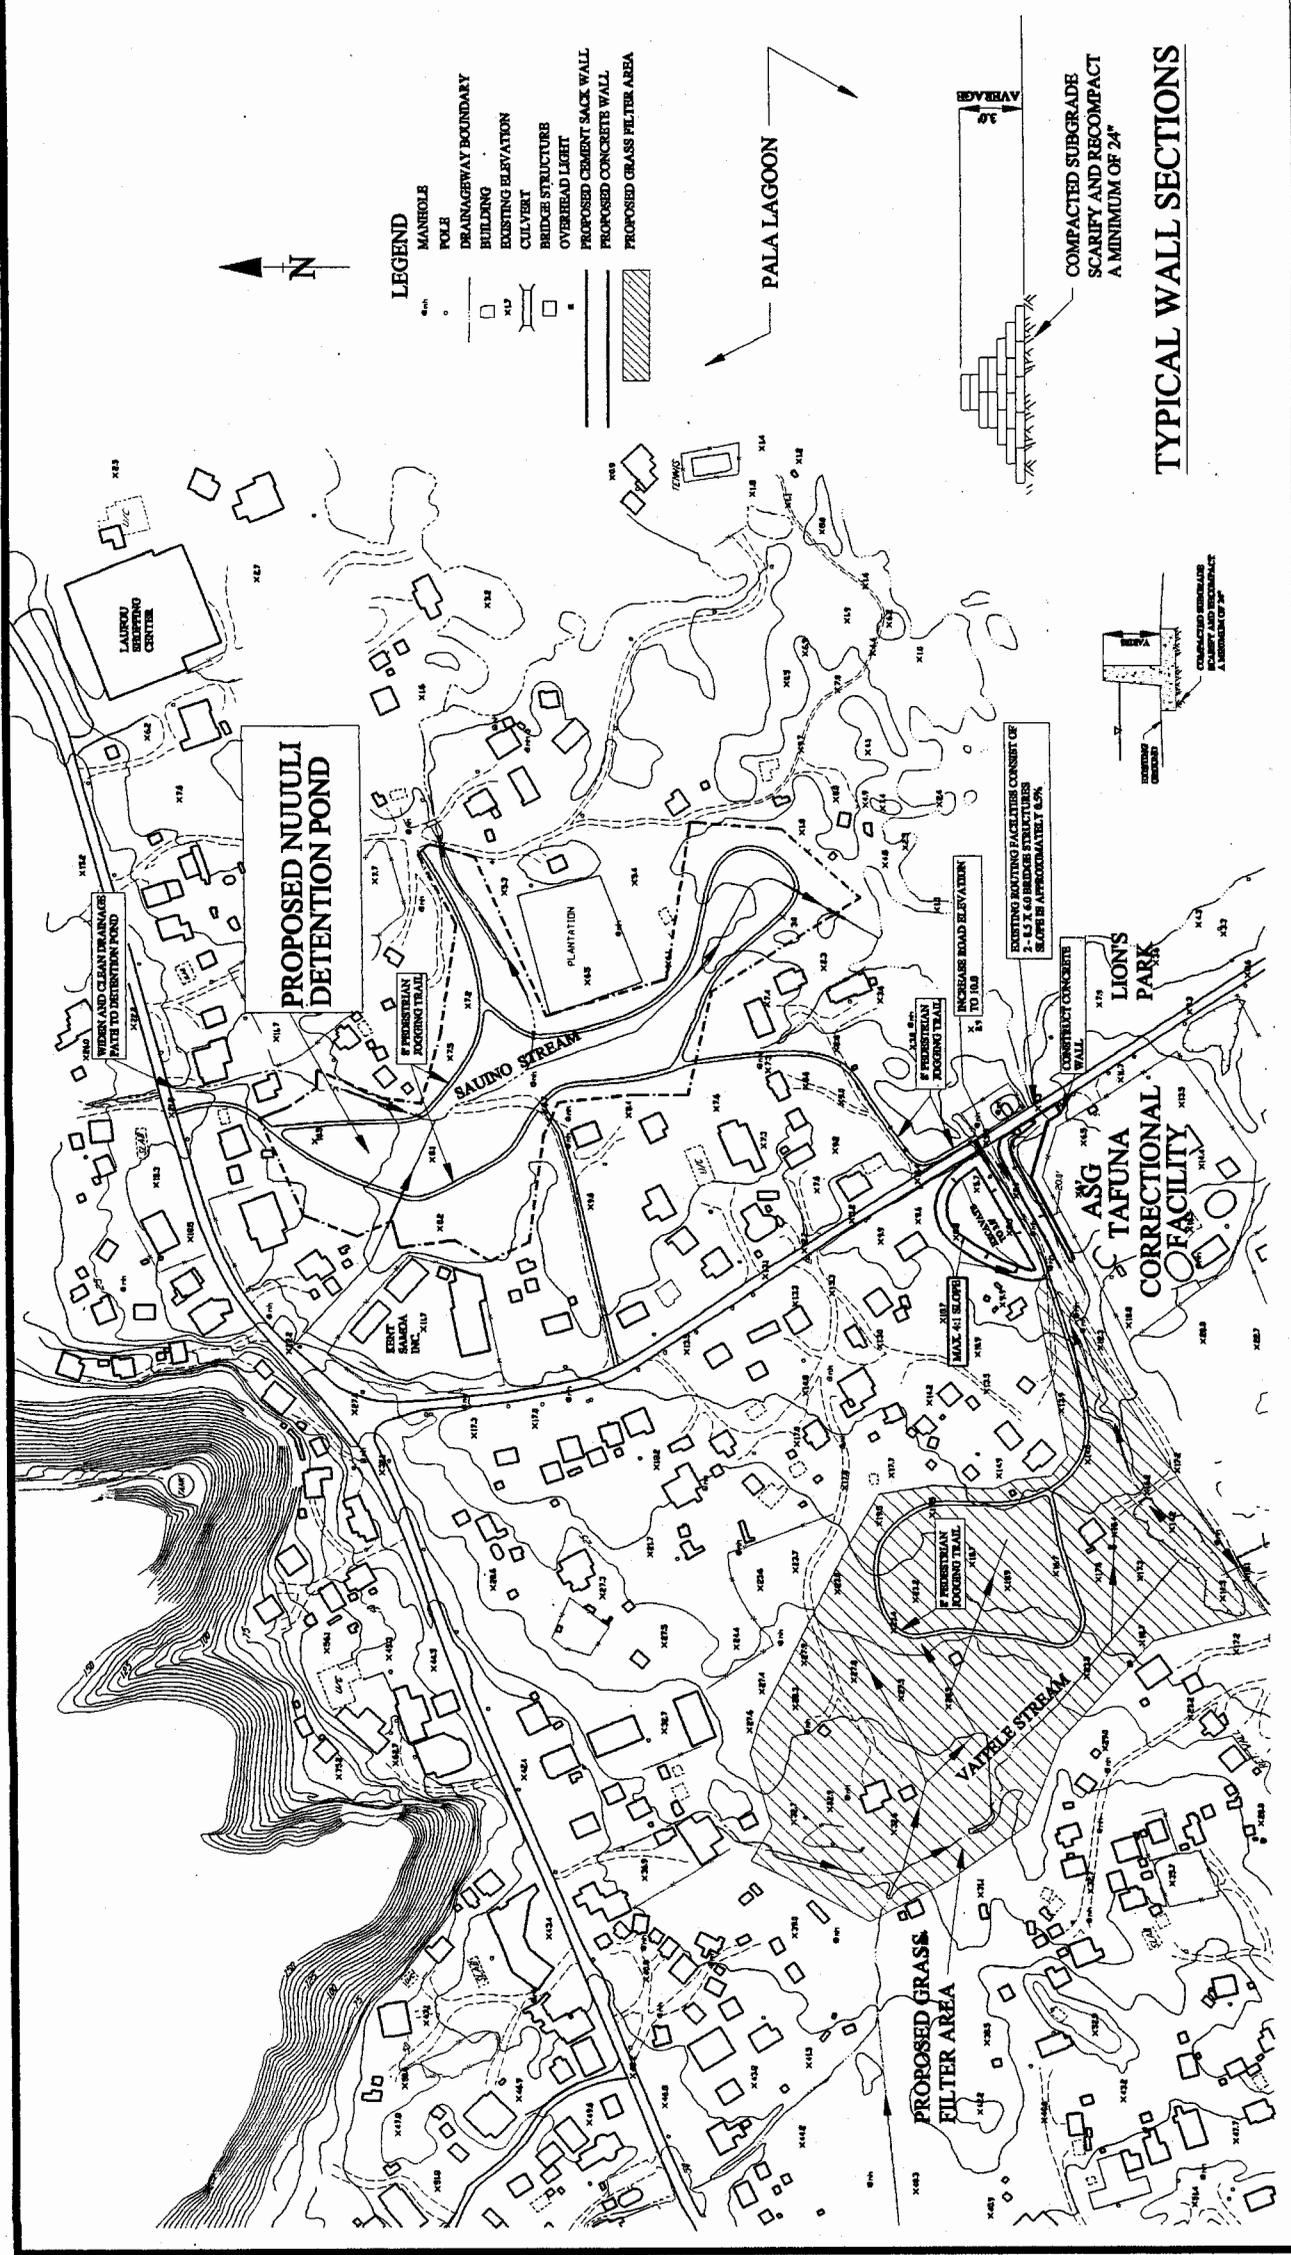
Figure 2-6

- LEGEND**
- MANHOLE
 - POLE
 - DRAINAGEWAY BOUNDARY
 - BUILDING
 - EXISTING ELEVATION
 - CULVERT
 - BRIDGE STRUCTURE
 - OVERHEAD LIGHT
 - PROPOSED CEMENT SACK WALL
 - PROPOSED CONCRETE SACK WALL
 - PROPOSED GRASS FILTER AREA

Two potential sites offer some potential for stormwater detention opportunities (Figure 2-6):

The lower Vaitele Stream drainage is located south of the primary shoreline roadway and northwest of the American Samoa Government Tafuna Correctional Facility and Lion's Park (Figure 2-6). This area primarily contains residential land uses. Some commercial banana production is also made in this area.

Several man-made swales from the defined Vaitele Stream course would be constructed to spread out future stormwater flows (Figures 2-6 and 2-8). Each swale would be approximately one-foot deep and 2 feet wide. The swales, which would extend some 100 to 200 feet in length, would be directed toward a grass filter area that would enable some filtering of sediments from lower stormwater flows.

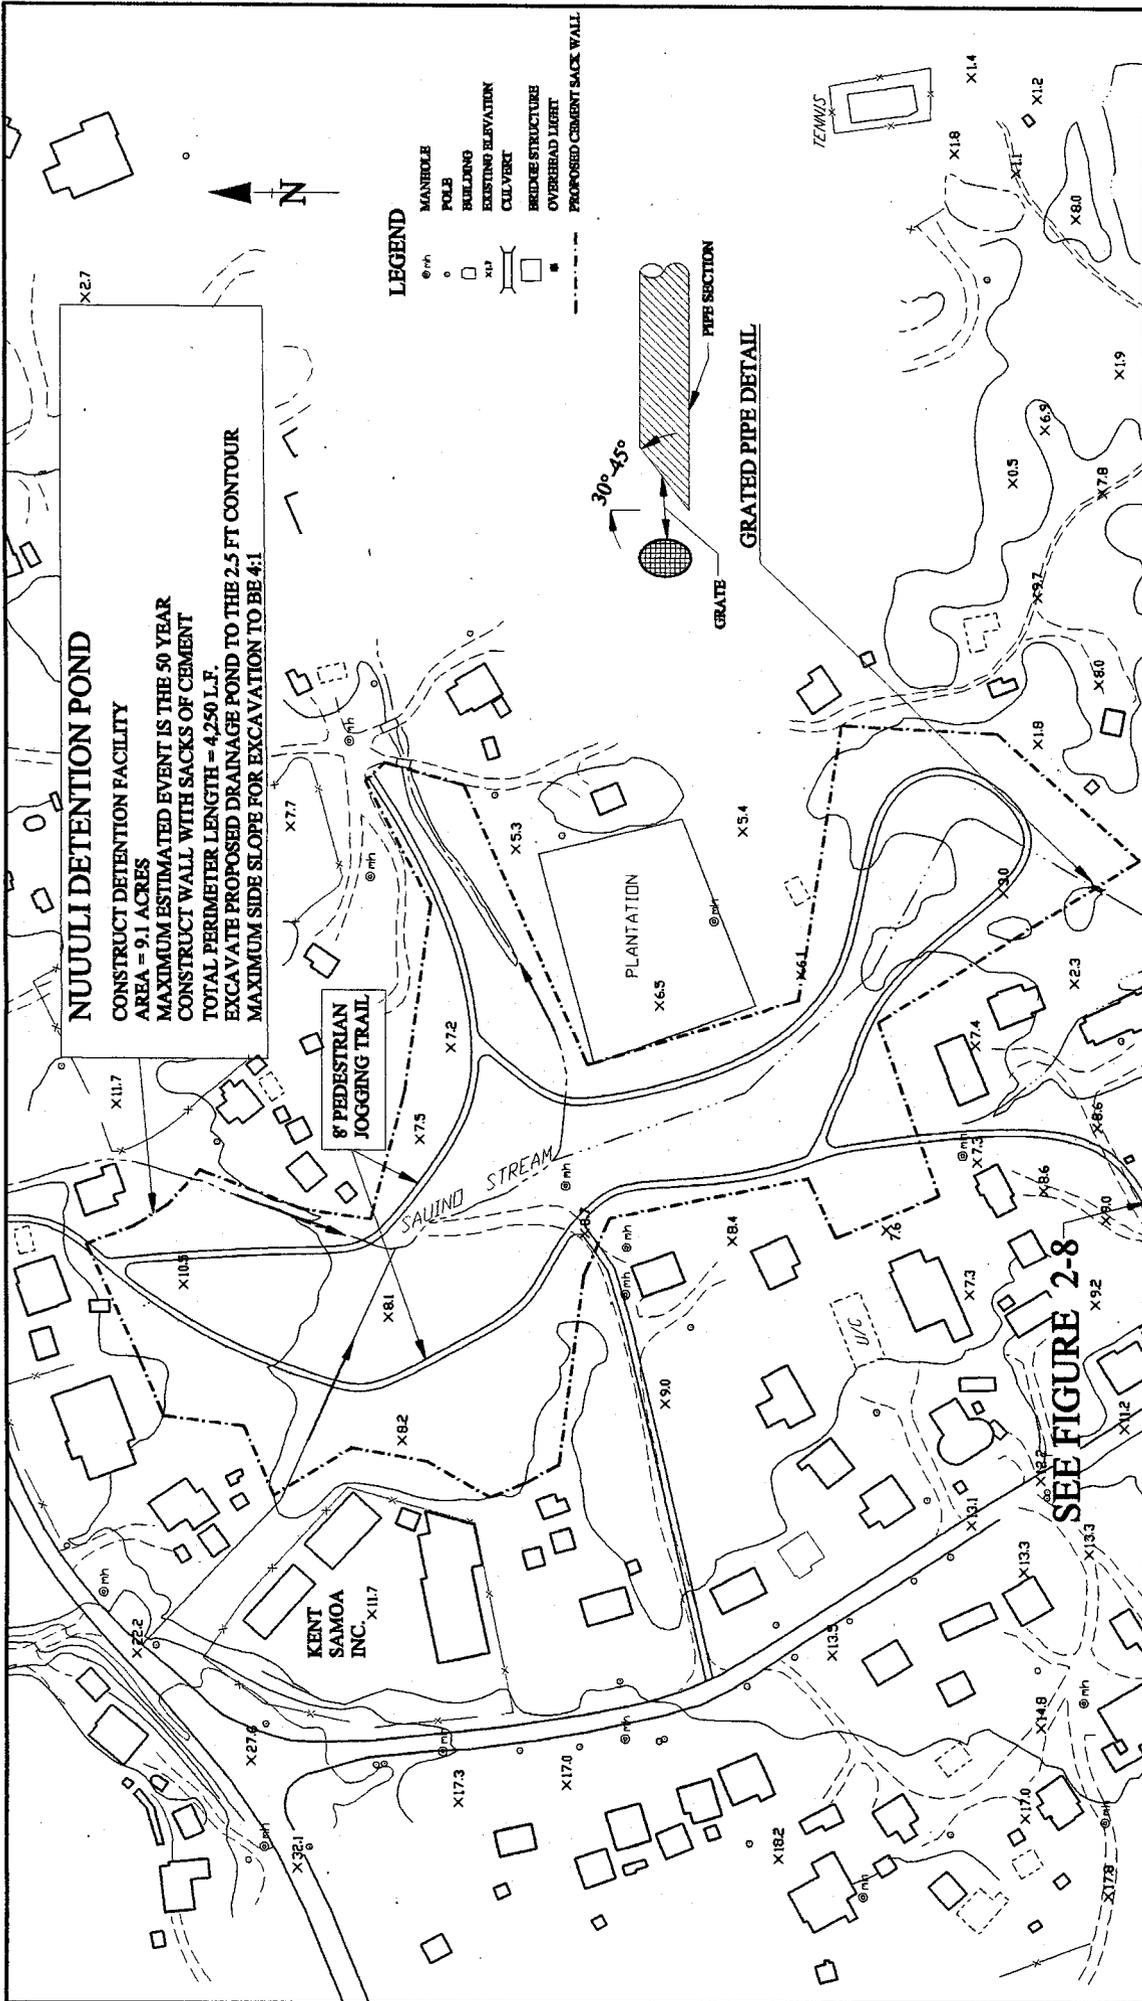
**PROPOSED NUULI DETENTION POND
 LOWER SAUNINO STREAM**
 Scale: 1"=300' **Figure 2-7**

The lower Sauino Stream drainage passes underneath the primary shoreline roadway on the west side of the Nuuli Cinema complex in Nuuli. While much of the lower Sauino Stream drainage is already urbanized, a small undeveloped area lies seaward of the primary shoreline roadway and existing commercial facilities. A 9.1-acre area, which is situated immediately east of Kent Samoa, Inc., offers a potential stormwater detention opportunity (Figure 2-7).

The proposed detention area (Figure 2-7) would be excavated to the 2.5-foot contour. Roughly five to six feet of soil would initially be excavated from the detention area.

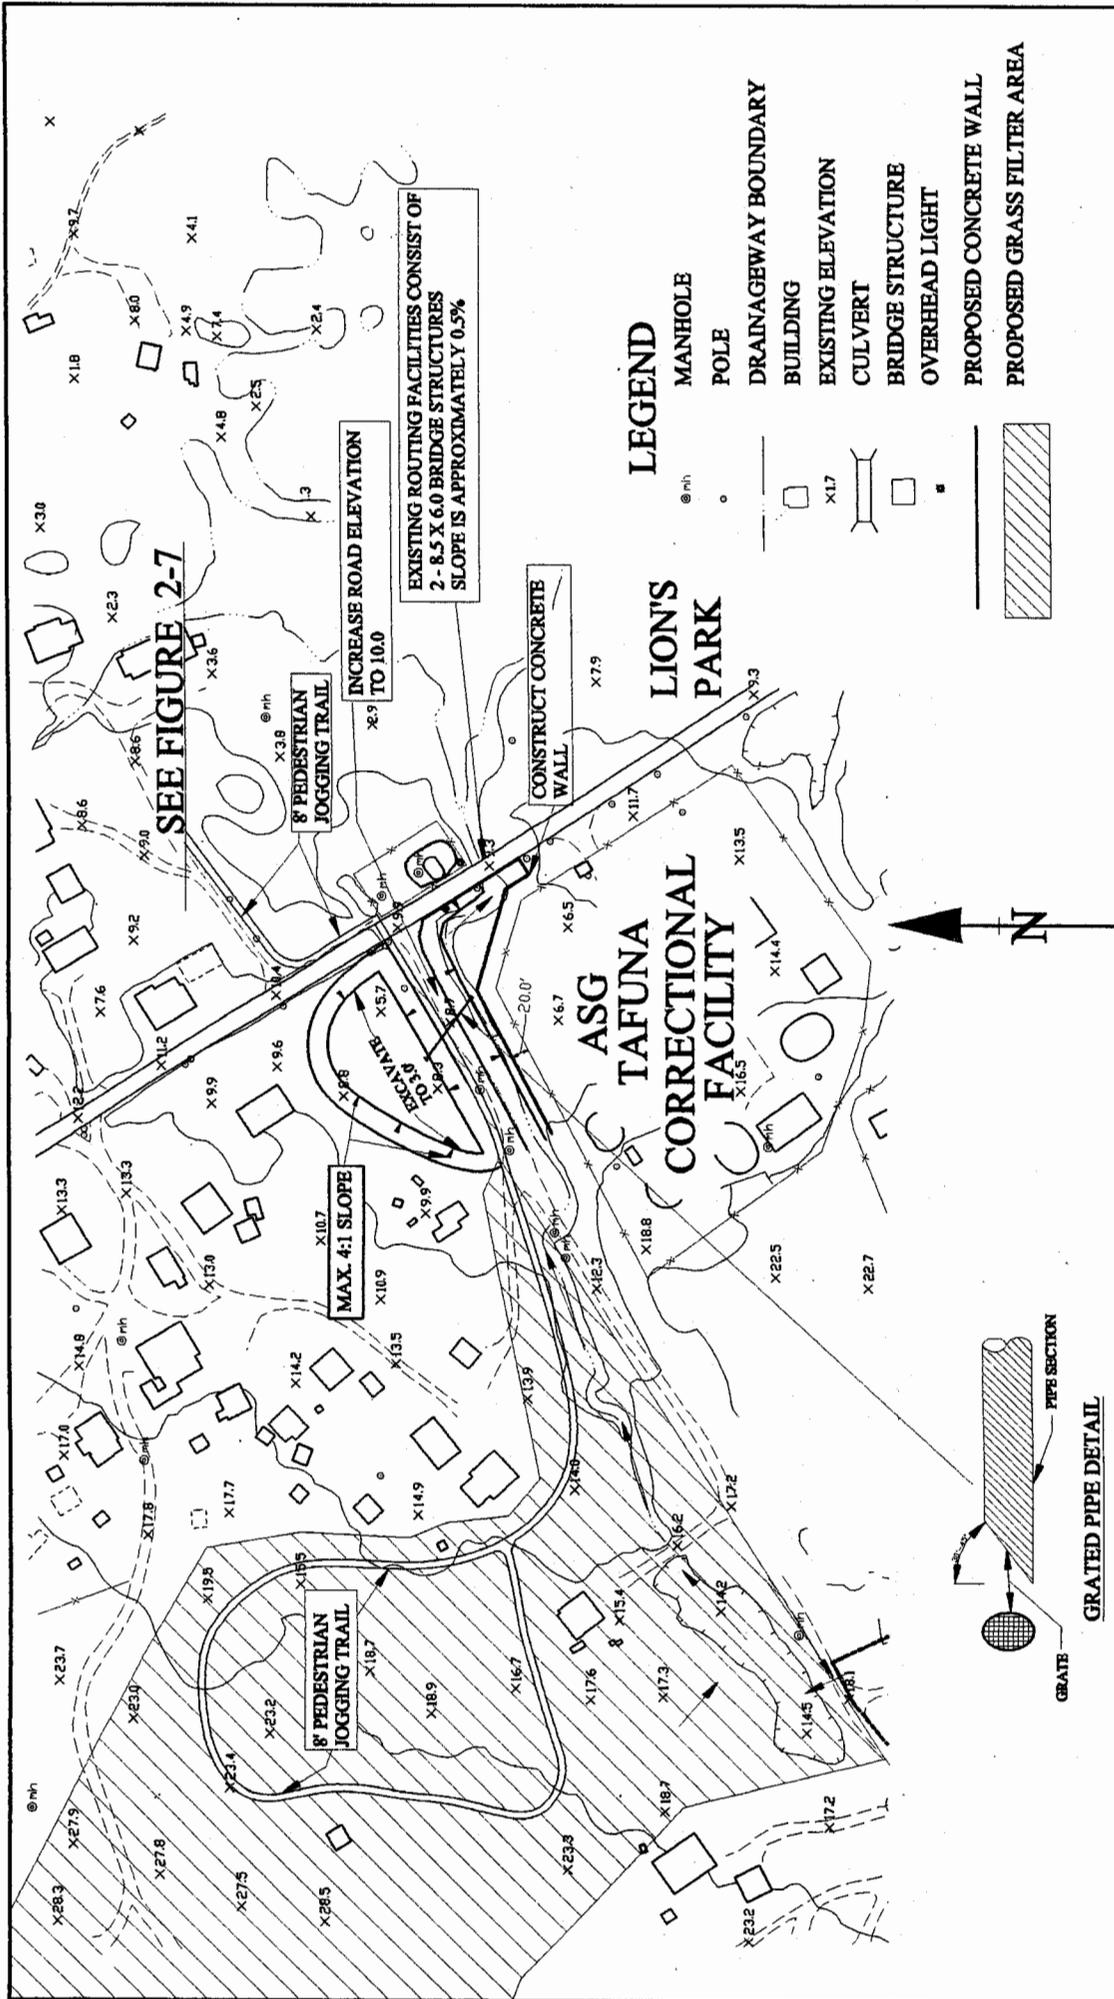
**PROPOSED STORMWATER MANAGEMENT
LOWER VAITELE STREAM**
Scale: 1"=300' Figure 2-8

The grass filter would make use of California grass or other vegetative cover. The grass would be maintained on a monthly basis; the height of the vegetative material would not be permitted to grow beyond two feet in height. Sediment trapped by the filter would need to be removed approximately once every three months.

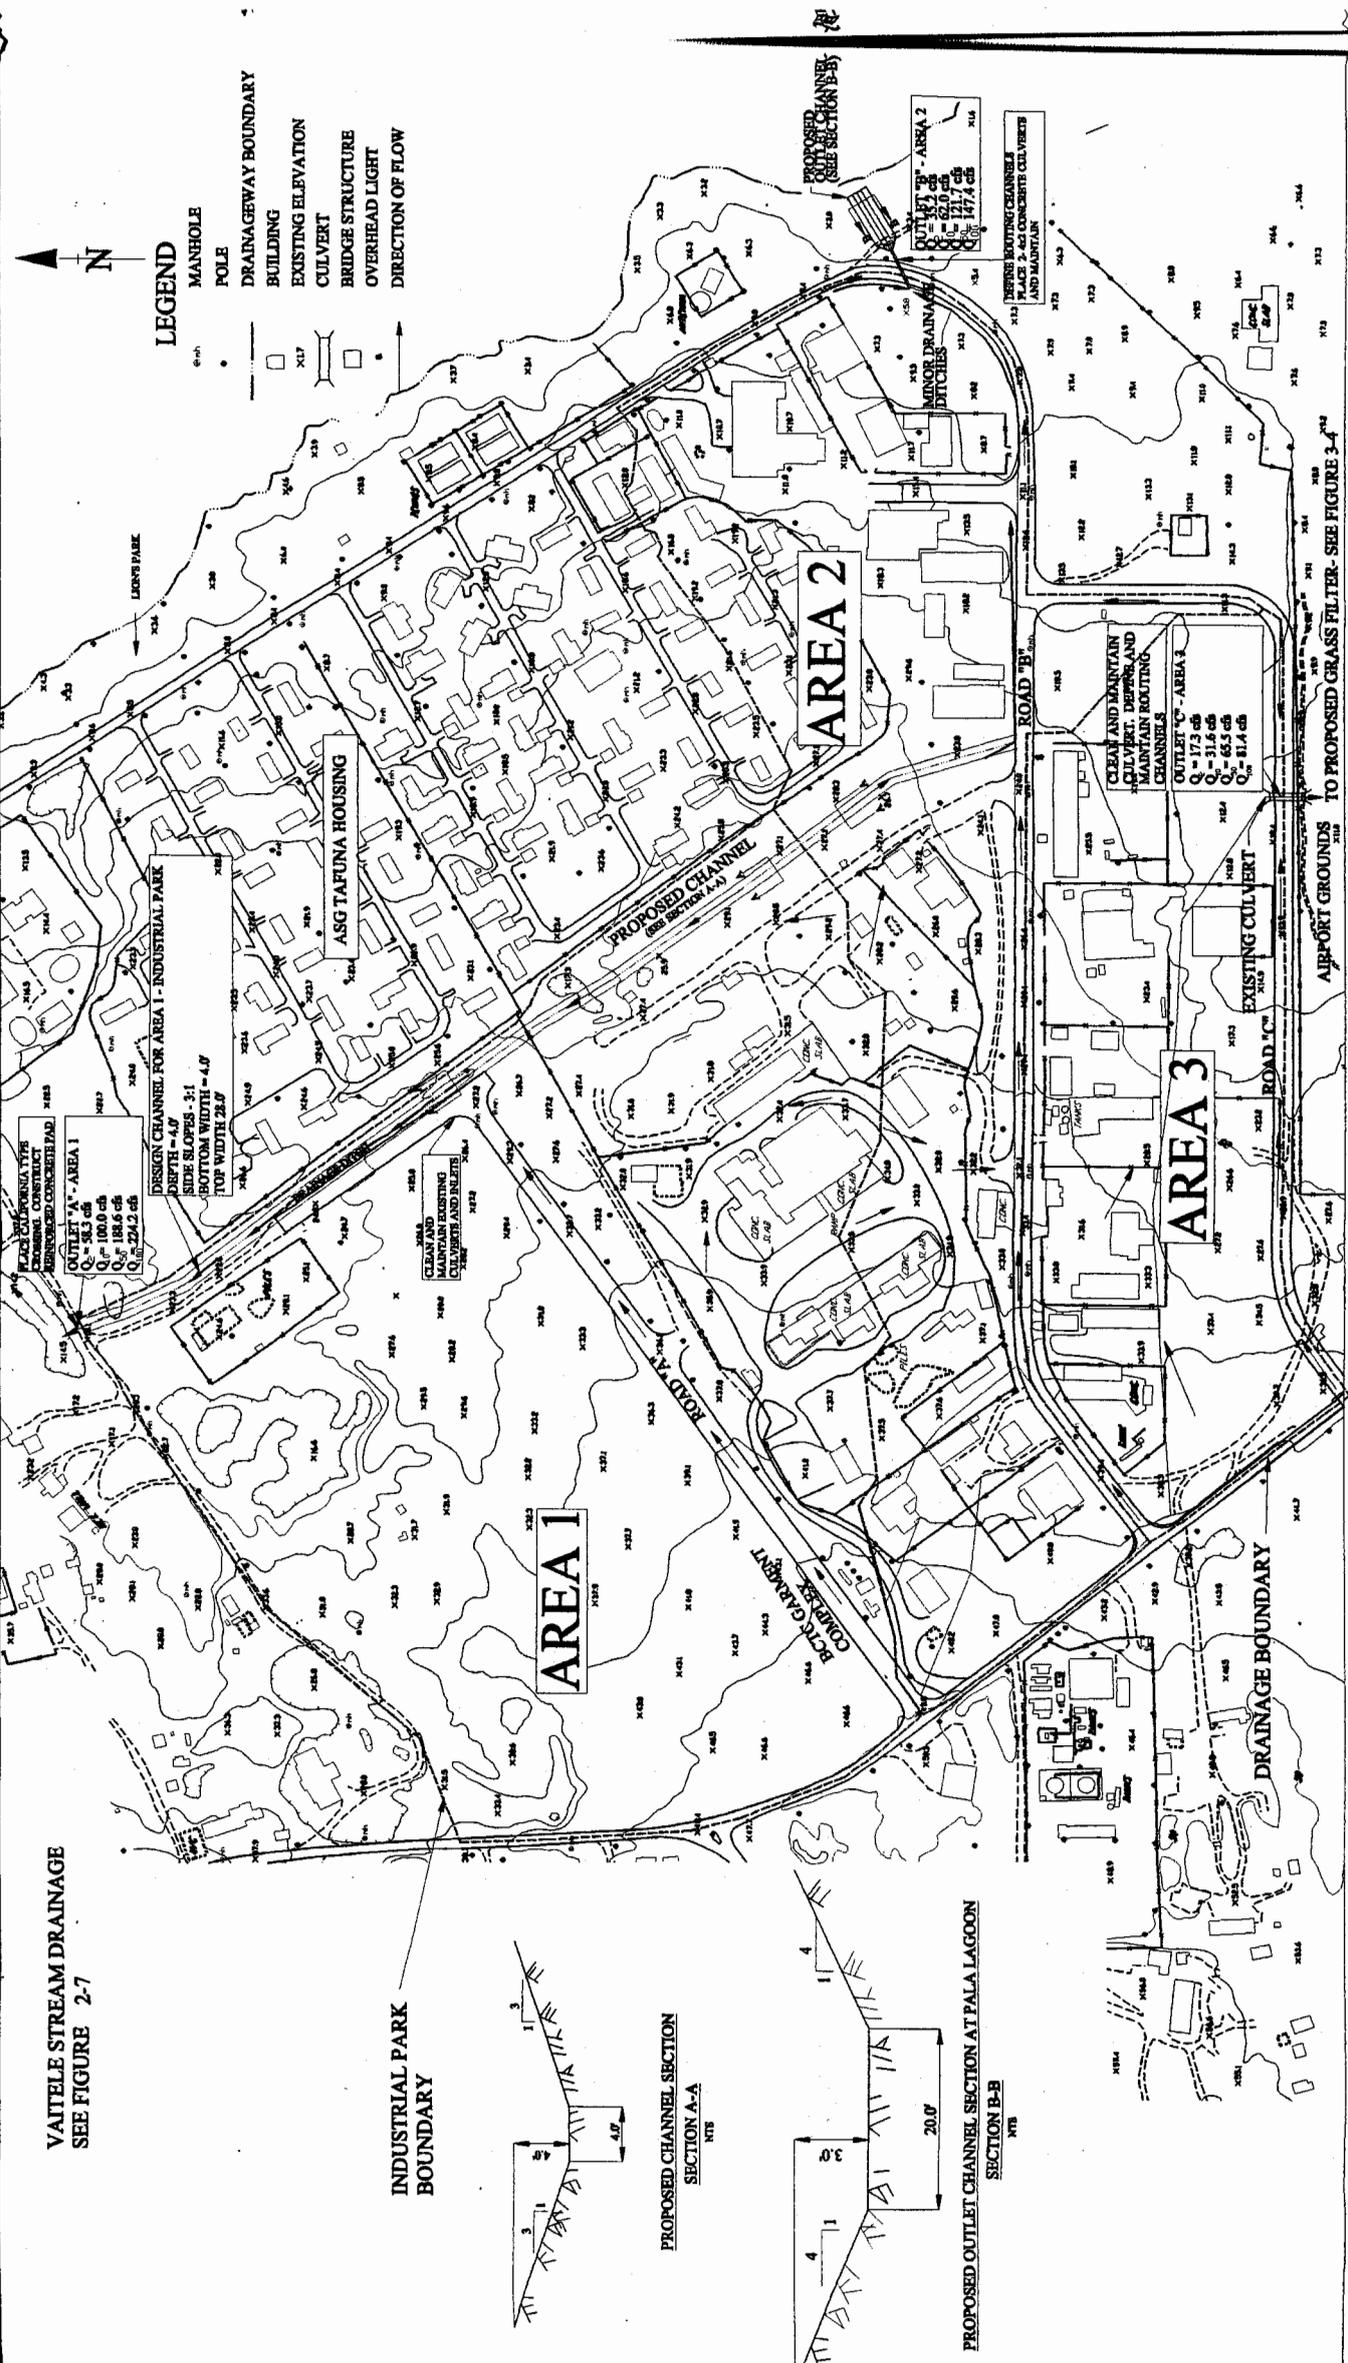
DANIEL INOUE INDUSTRIAL PARK
PROPOSED STORMWATER MANAGEMENT
Figure 3-3

Storm drains and culverts in the Industrial Park should be periodically maintained to permit the effective transport of stormwater runoff to downstream drainageways (Figure 3-3). Otherwise, localized flooding in selected areas of the Industrial Park will continue.

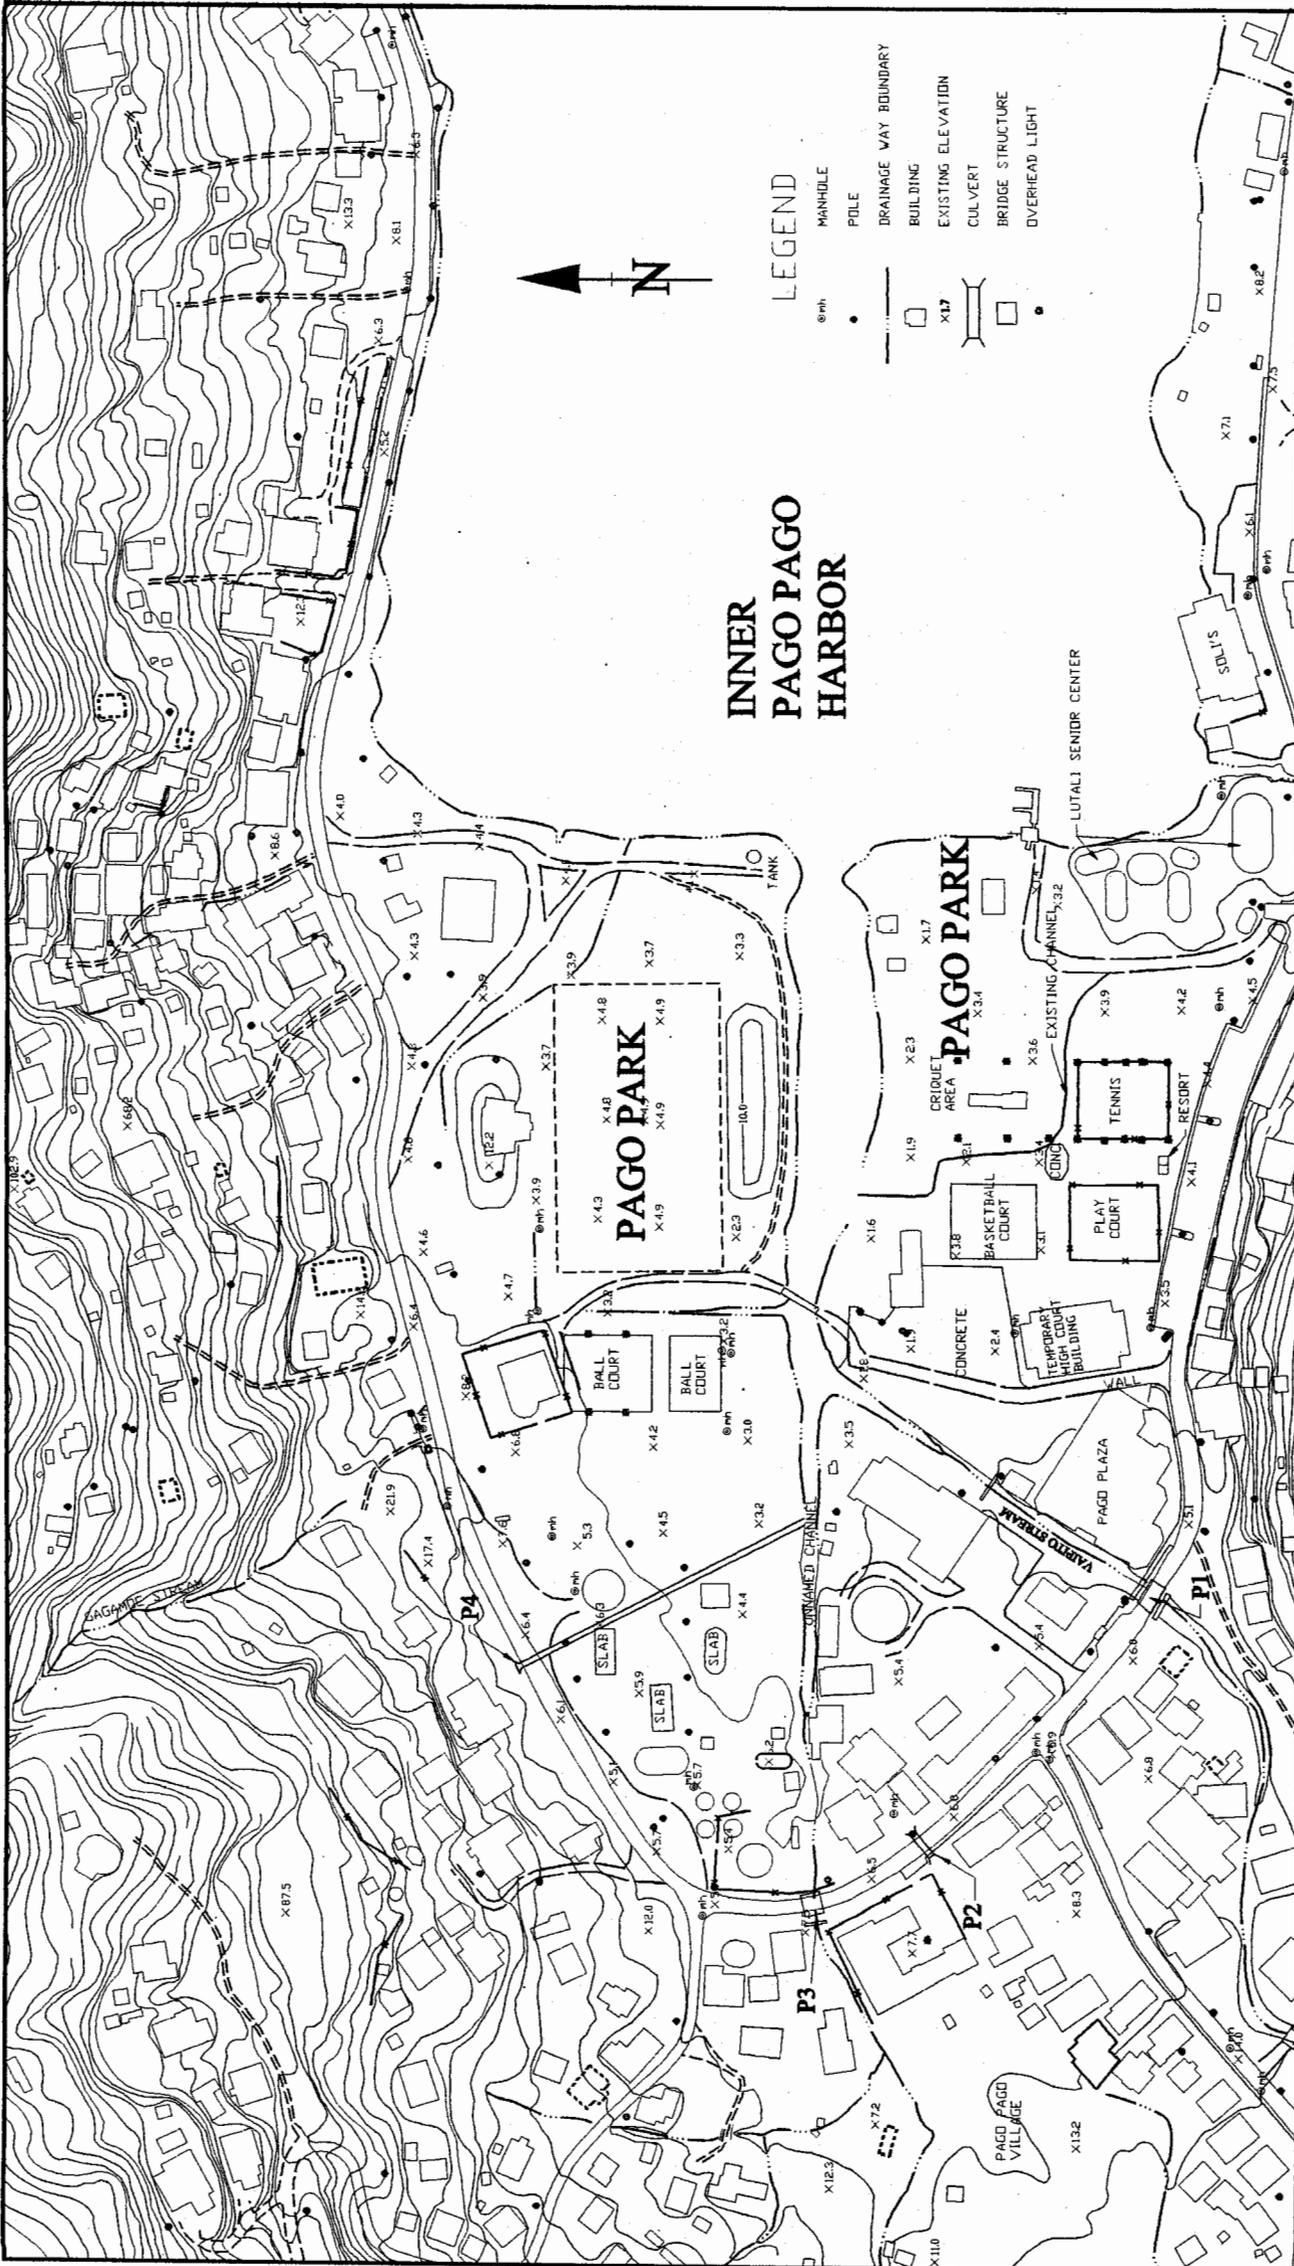
INNER PAGO PAGO HARBOR
LOWER VAIPITO STREAM DRAINAGE
EXISTING STORMWATER MANAGEMENT

In May, 1998, these culverts were characterized by a significant amount of vegetation and debris. Regular periodic maintenance of each culvert is required to make effective use of the culverts and reduce flood potential along the primary shoreline roadway.

With regular maintenance, Culverts P1 and P3 are sized can accommodate stormwater flows generated from a 10-year storm. However, in the case of Culvert P3, an existing concrete I-beam underneath the primary shoreline roadway will need to be removed to achieve a 10-year storm capacity.
