AMERICAN SAMOA WATERSHED PROTECTION PLAN

Volume 4: Stormwater Management Evaluations

**Nuuuli Watershed
Daniel Inouye Industrial Park
Pago Pago Watershed
Vatia Watershed
Tula Watershed
Leone Watershed**

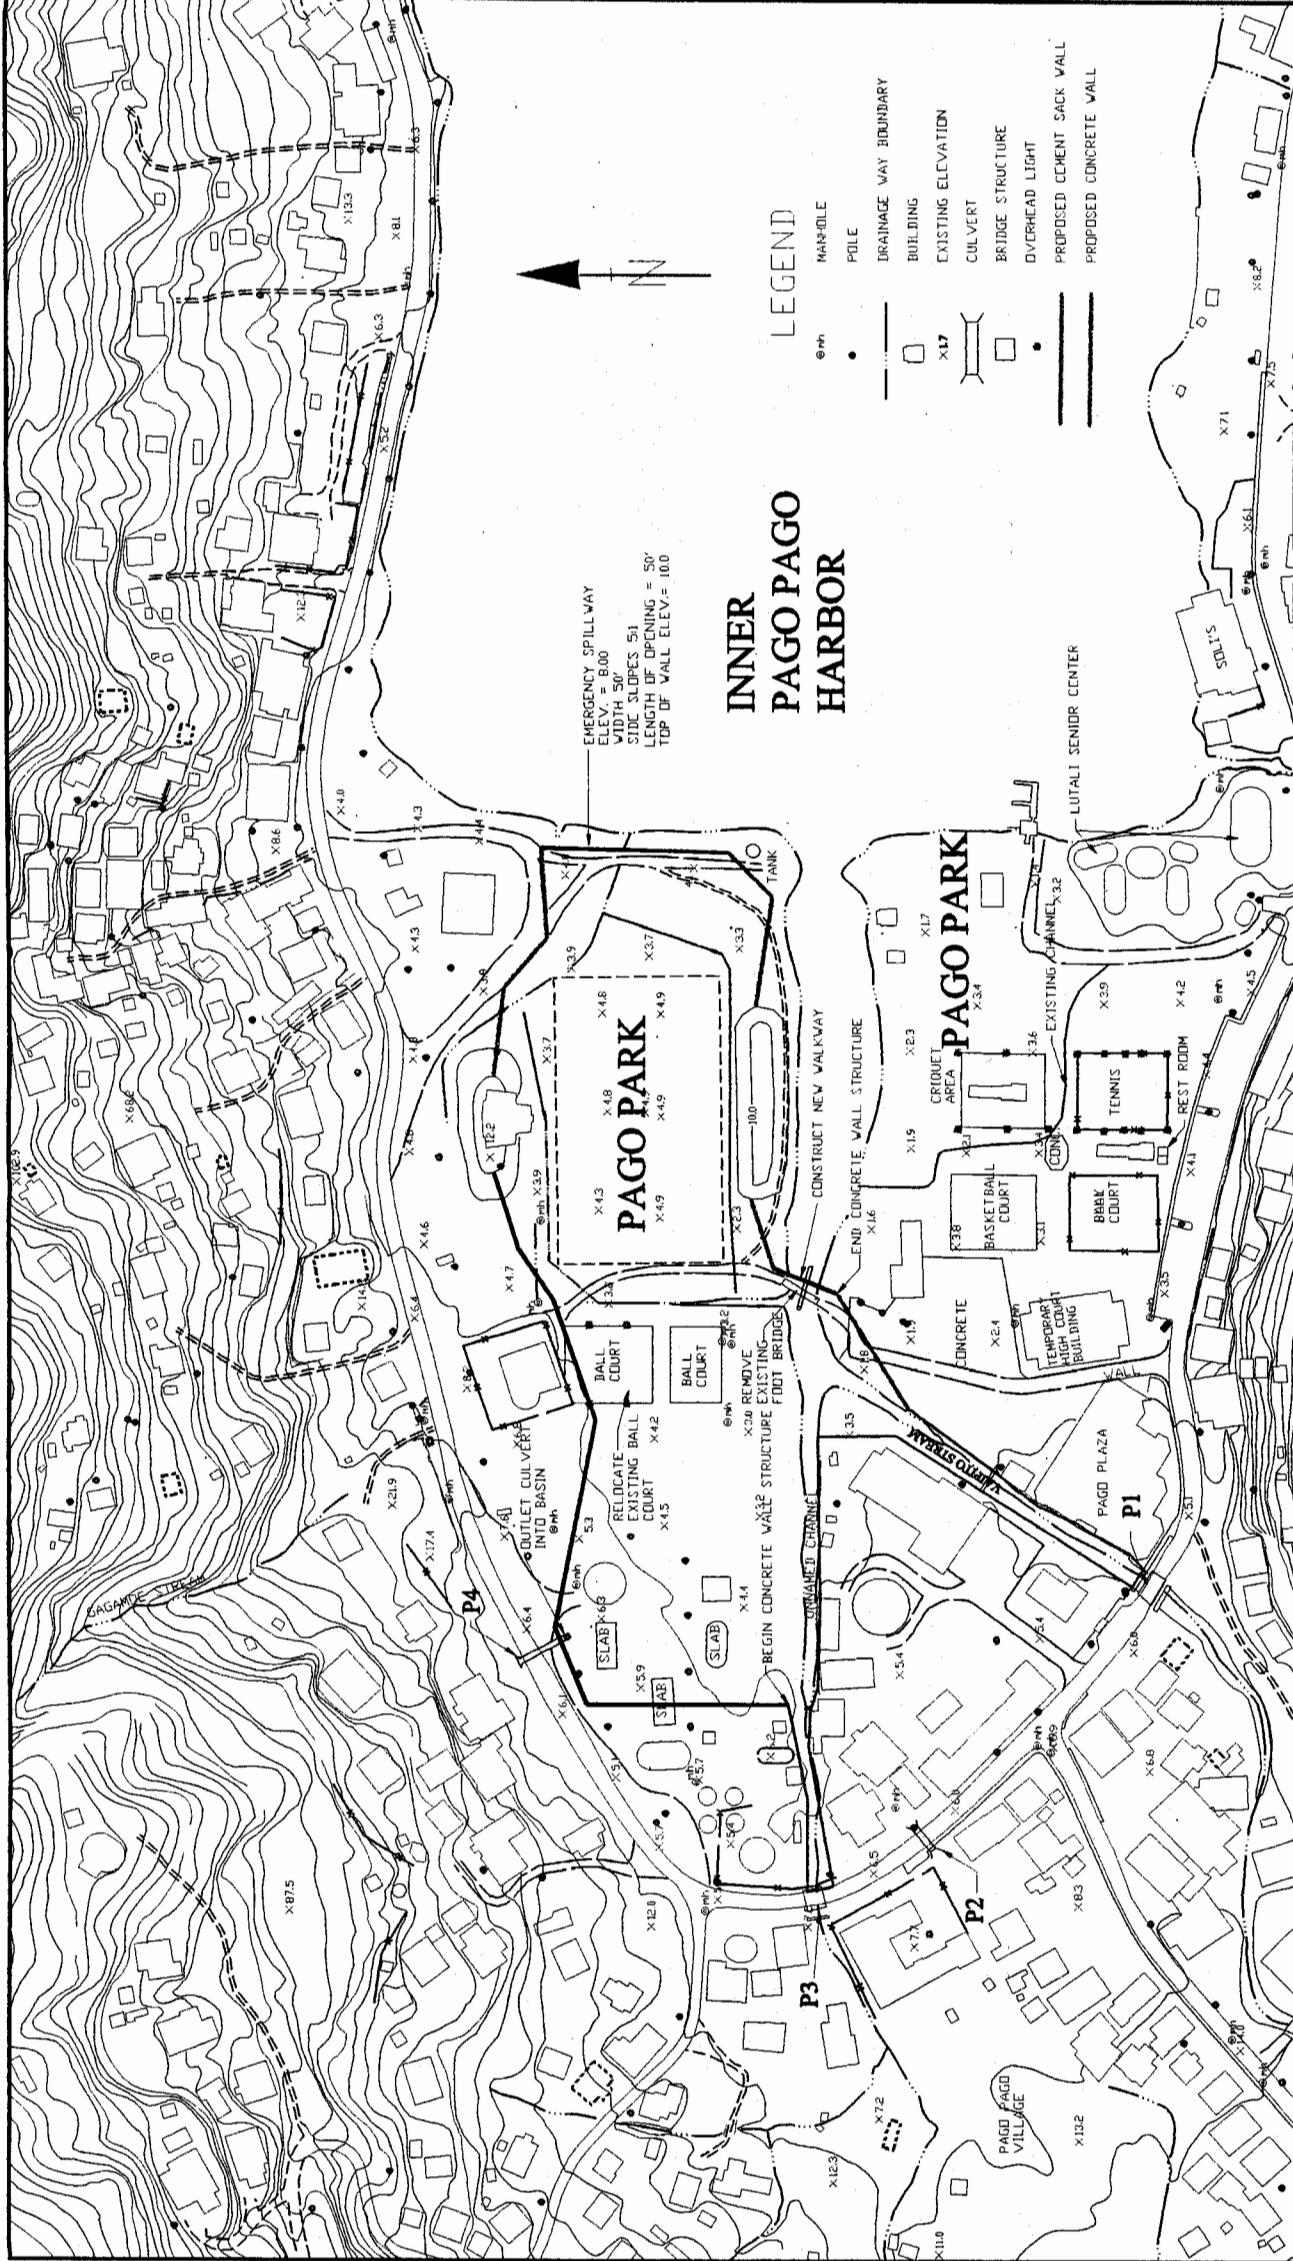
**LOWER VAIPITO STREAM DRAINAGE
 PROPOSED STORMWATER MANAGEMENT**

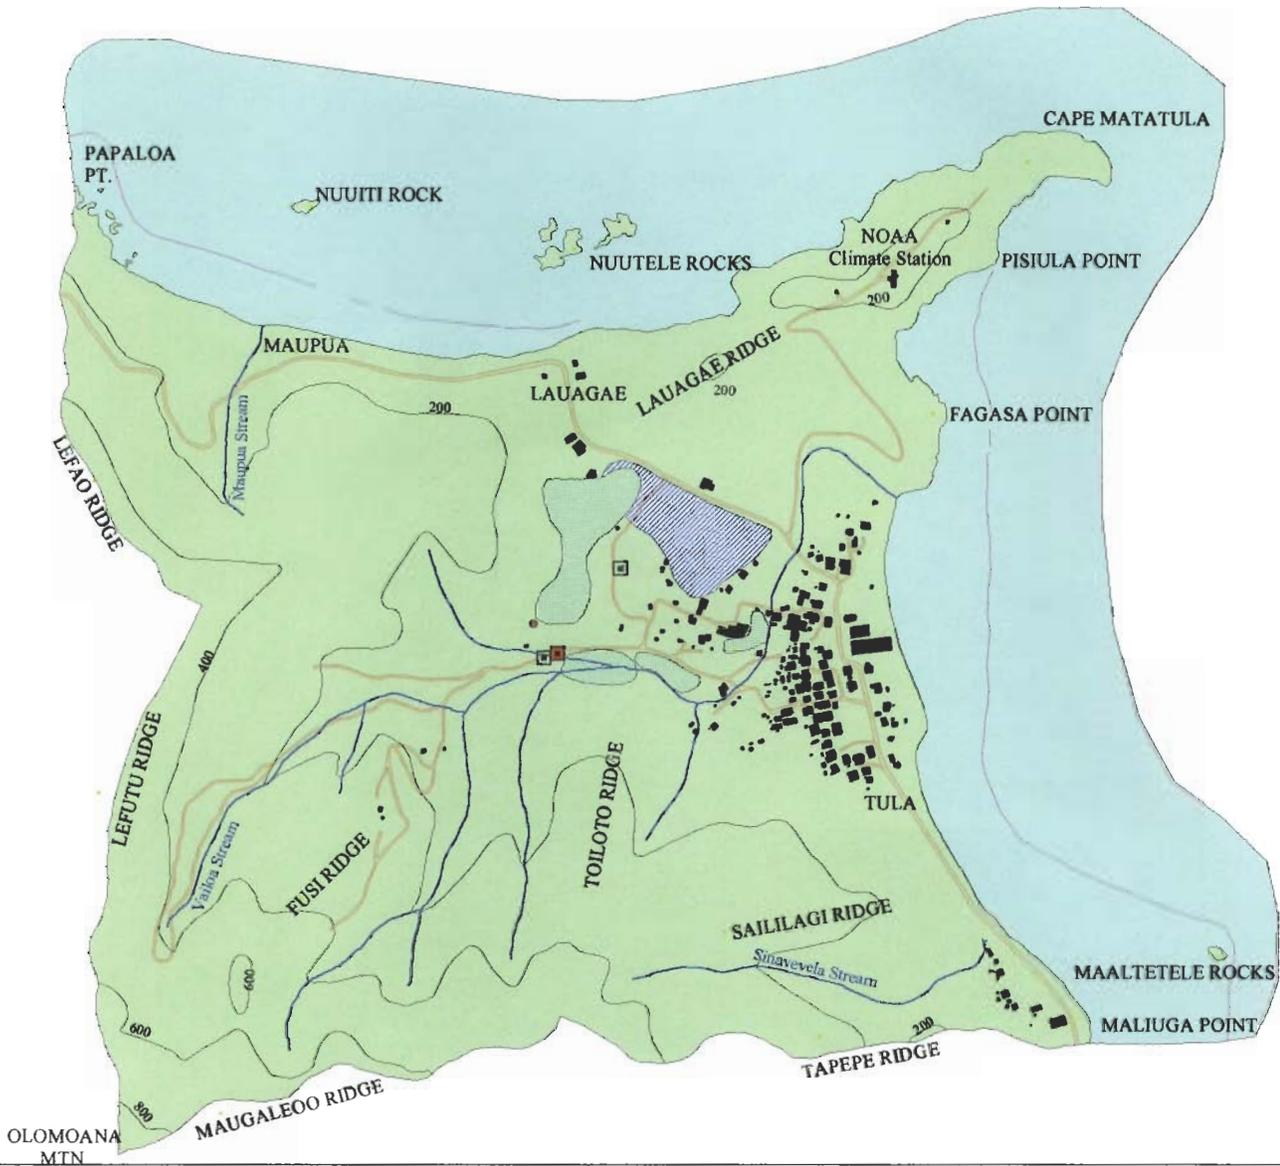
Figure 6-1

Tula Watershed

Existing Conditions

The Tula watershed planning area, which is defined by natural resource managers in American Samoa and the American Samoa Watershed Protection Plan, includes approximately 0.6 square mile of land area (Figure 6-1) along the northeast tip of Tutuila. Within this area, there are three streams.

Vailoa Stream and its four tributaries represent the primary drainage in the watershed (Figure 6-1). This stream, which drains the east slopes Lefutu Ridge and the north slopes of Maugaleoo Ridge, passes through portions of the inhabited village area. A man-made swale transports surface runoff through the west side of the Village and, eventually, connects to a defined stream channel on the north side of Tula. Vailoa Stream discharges along the shoreline approximately 750 feet north of Tula Elementary School.

Maupua Stream drains the north side of Lefutu Ridge and the east side of Lefao Ridge (Figure 6-1). This stream, which extends approximately 850 feet in length, discharges along the shoreline of the north side of the Tula watershed planning area, but does not drain within the inhabited village area.

Sinavevela Stream drains Saililagi Ridge and Tapepe Ridge, as well as the east slope of Maugaleoo Ridge (Figure 6-1). This stream discharges immediately upland of a few homes on the southeast side of the watershed planning area.

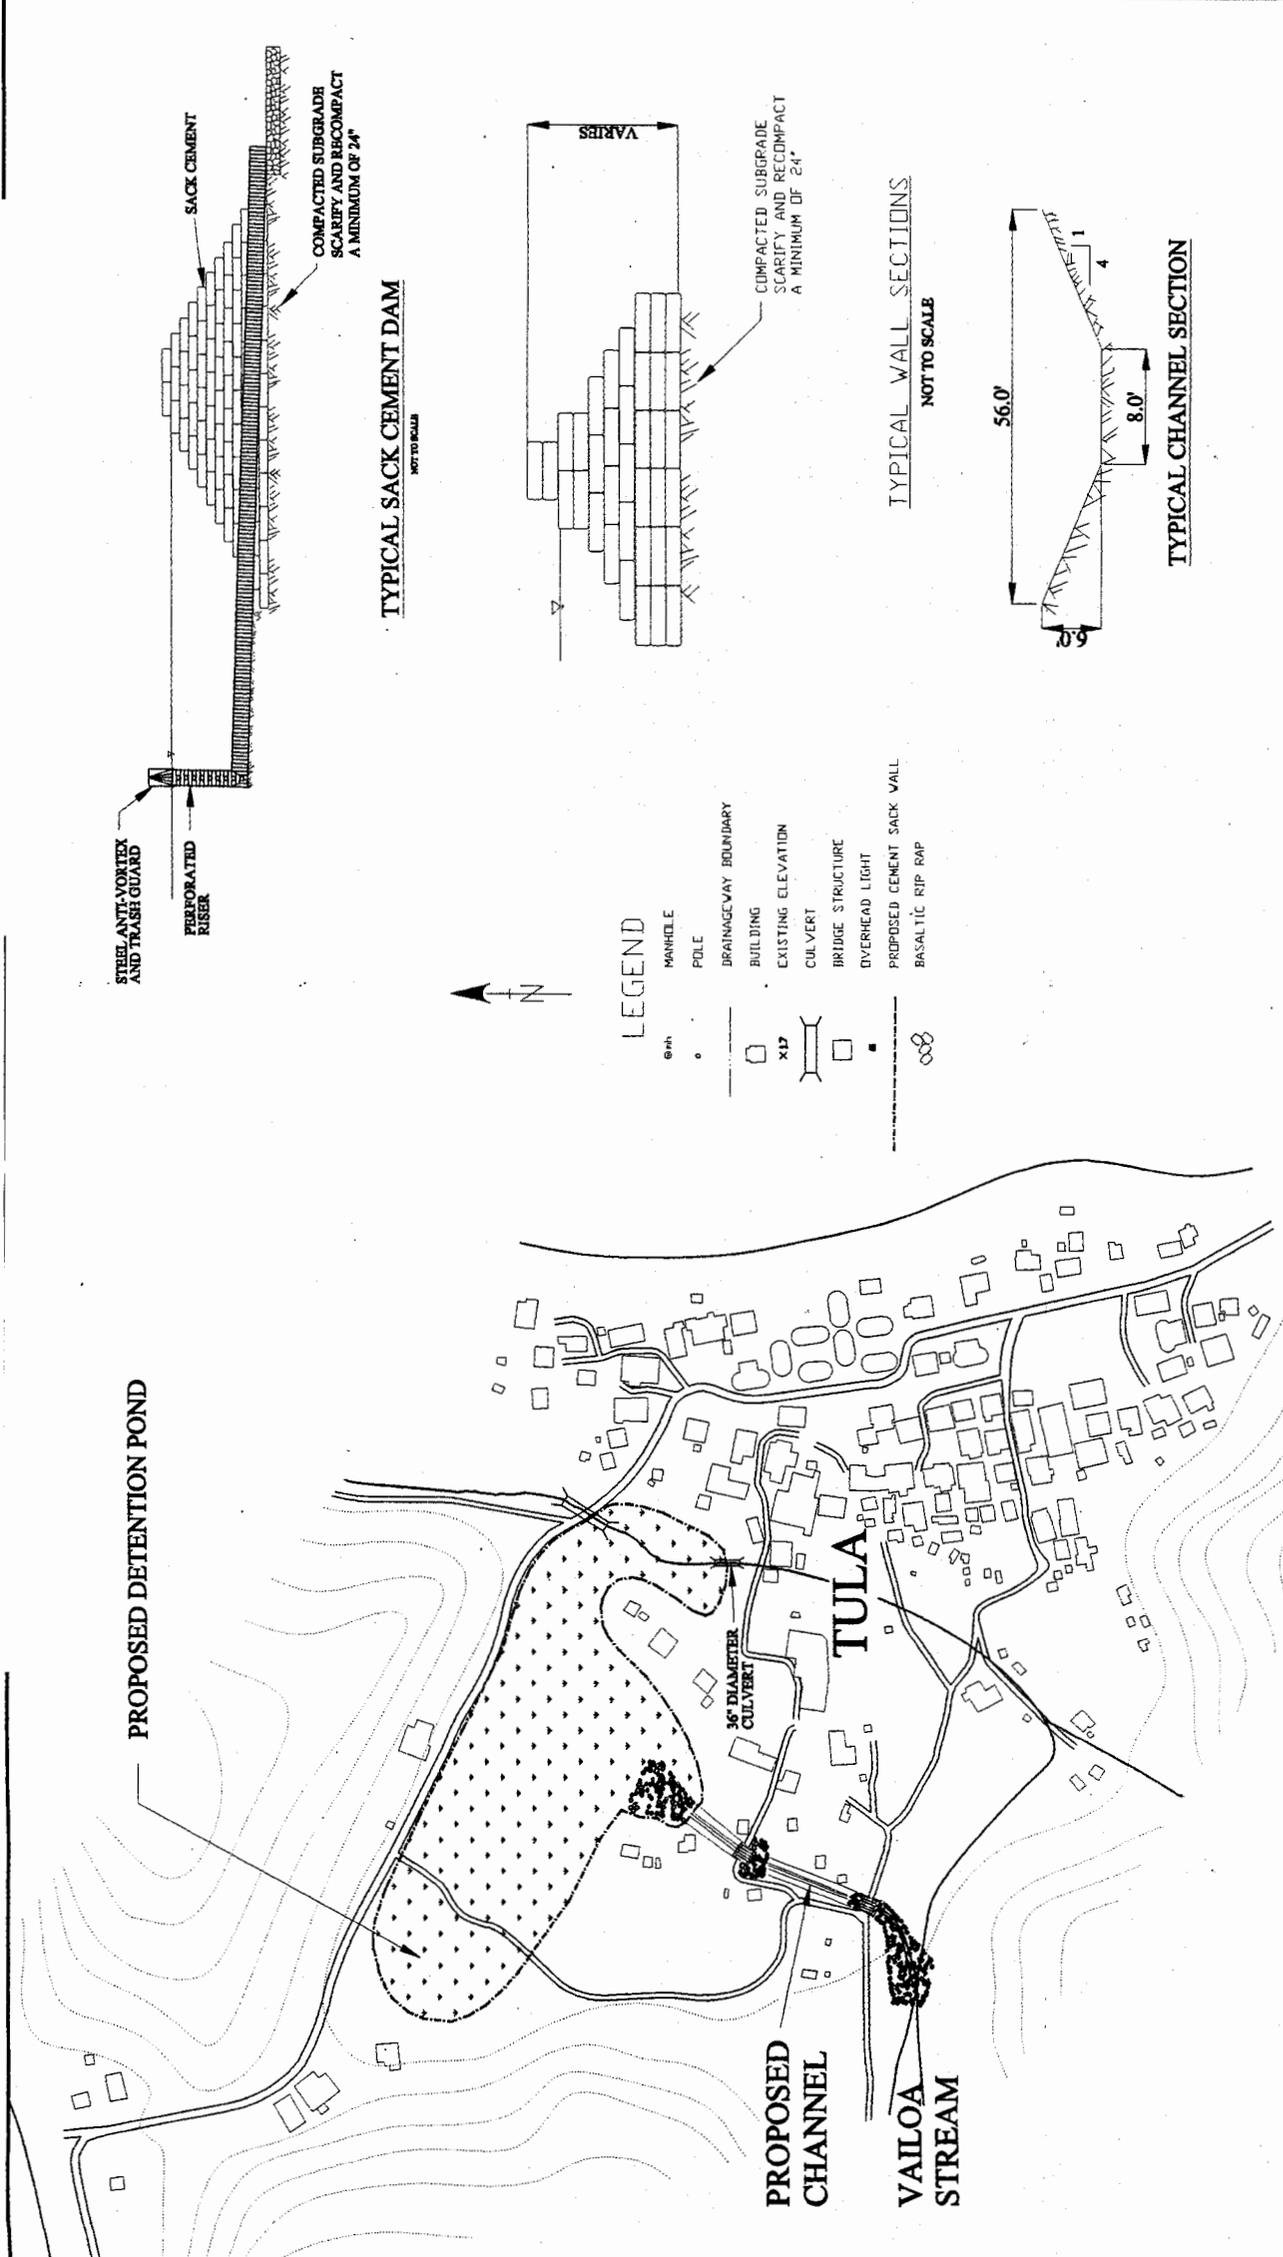
TULA DETENTION/SEDIMENT POND AND RELATED CHANNEL

The existing wetland would be excavated and expanded to include an additional 1.0-acre on the northeast side of the wetland. The expanded wetland would accommodate anticipated 100-year storm discharges. The wetland would be excavated to a depth of approximately three feet above sea level.

A nominal slope toward the east side of the wetland will be made to ensure a slower flow of stormwater to an existing culvert (T1) along Vailoa Stream that is situated underneath the primary shoreline roadway.

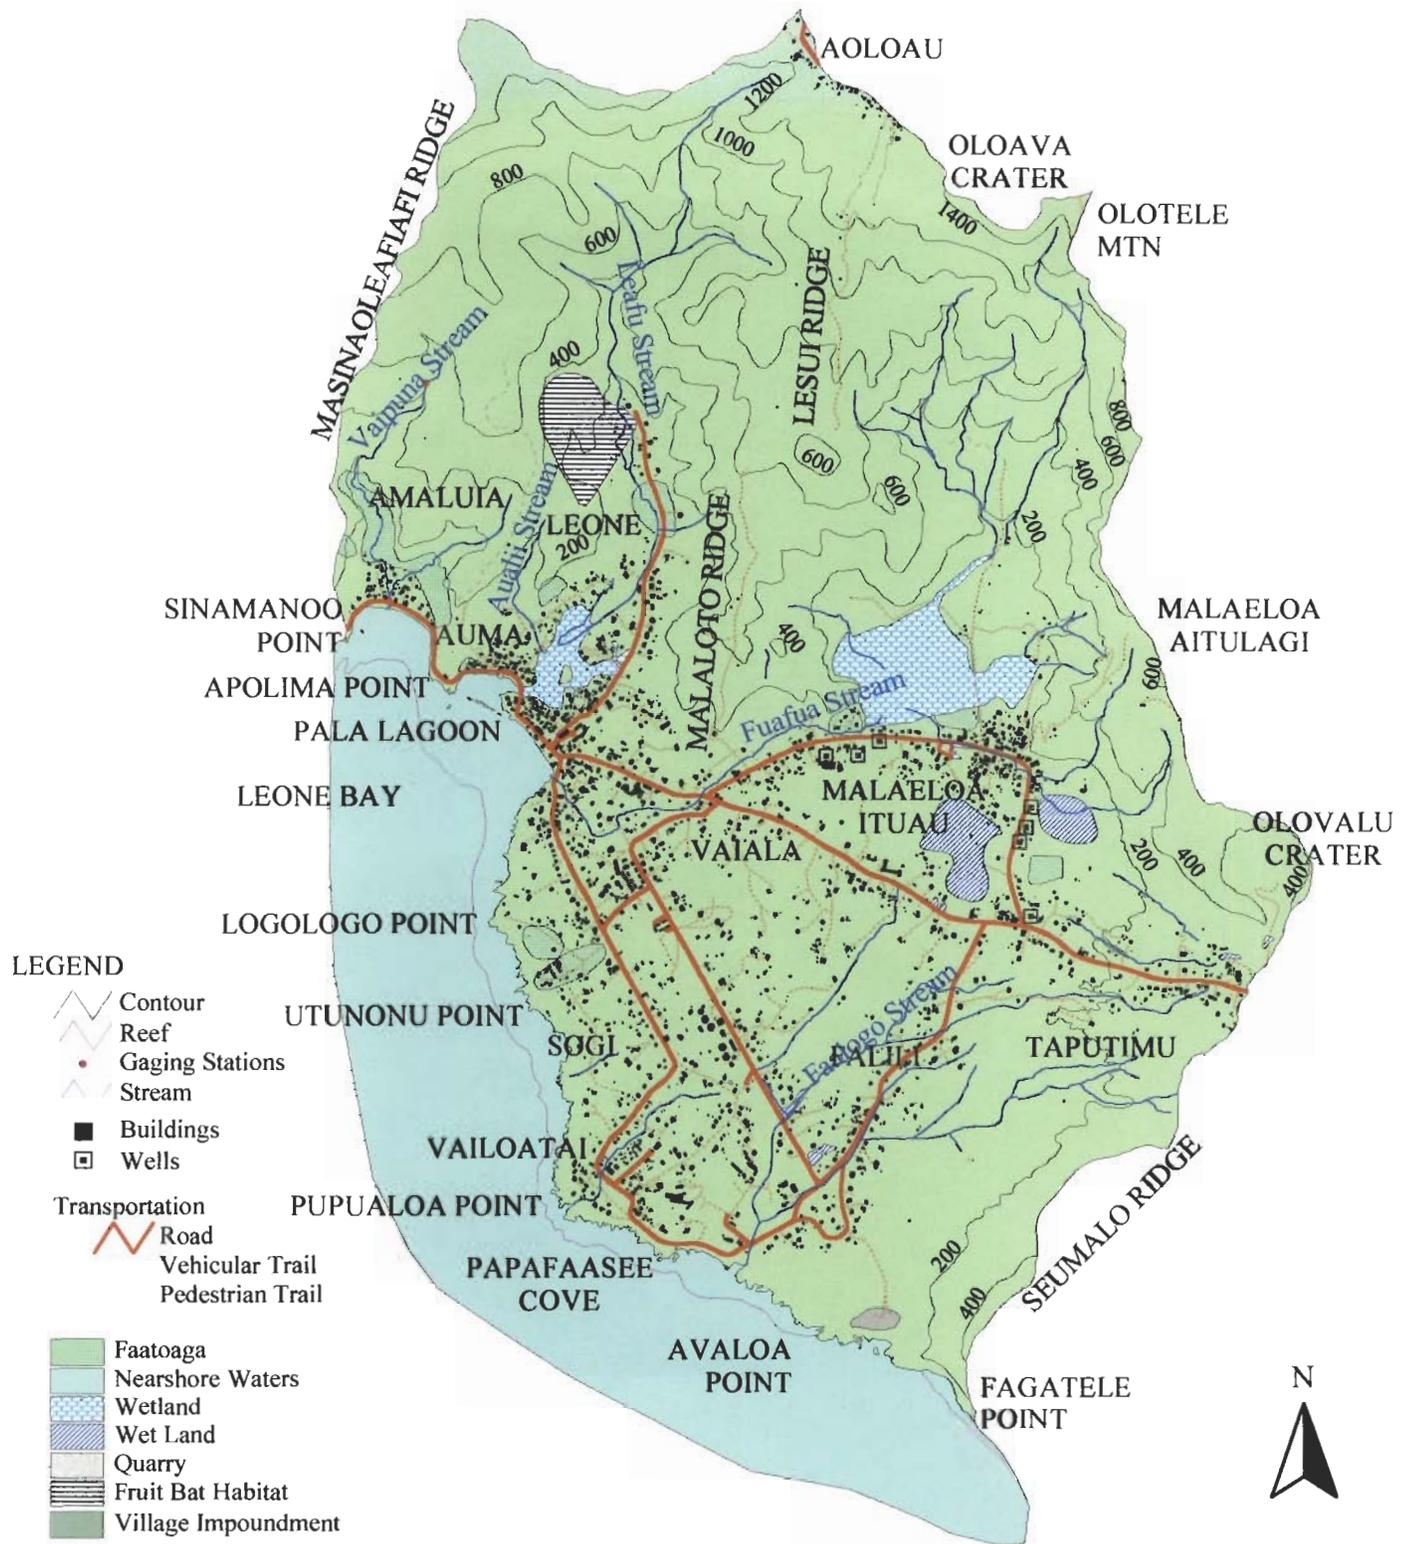
Leone Watershed
Existing Conditions

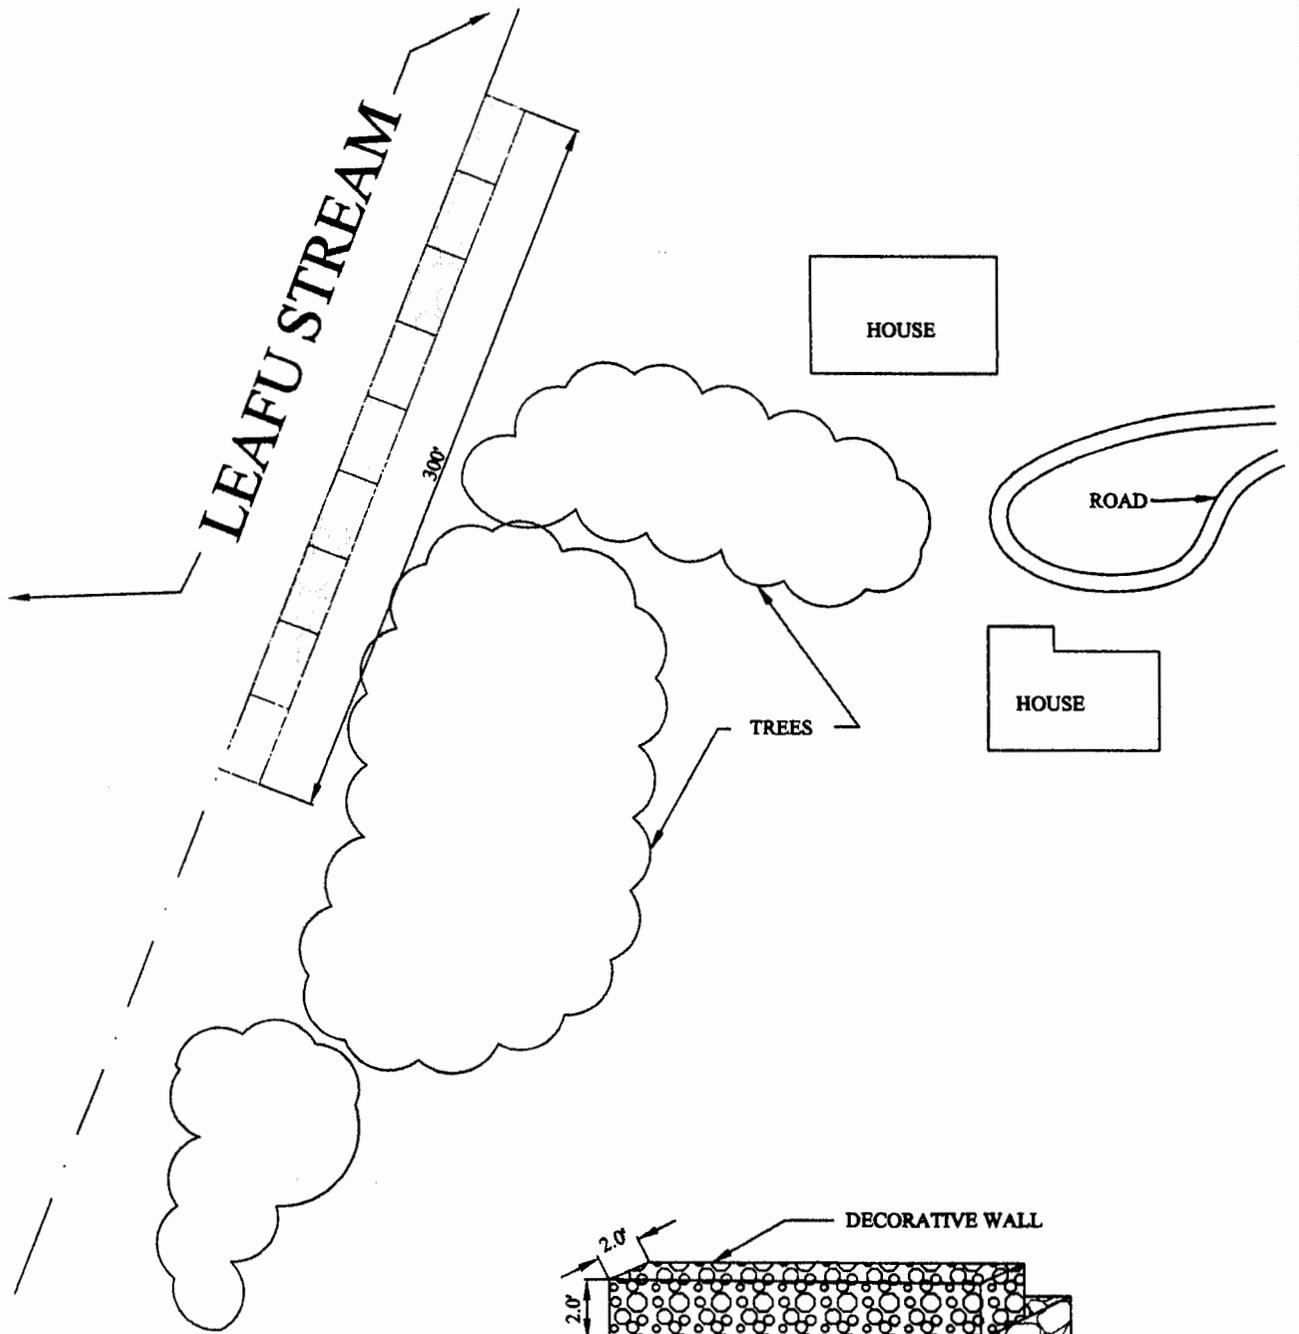
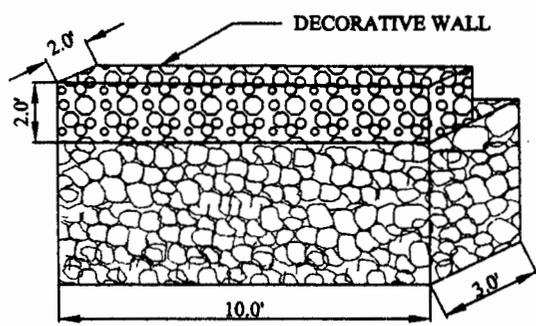
GABION WITH DECORATIVE WALL

Immediately west of existing residences and lawn areas, a trench would be excavated along 300 linear feet of the drainage area. A basaltic rock wall would be constructed within the trench using wire gabions approximately 4x3x10-feet in size to better define the east side of the stream and help direct future stream flows. Some basaltic rock treatment would be made on the east side of the wall to ensure that the wall would be attractive and complement existing residential development. The wall would also be back-filled with native soil to reduce the visual impact of the wire gabions (Figure 7-4).
