**American Samoa Environmental Protection Agency**

**Watershed Management and Protection Program**

**FY17 Annual Report**

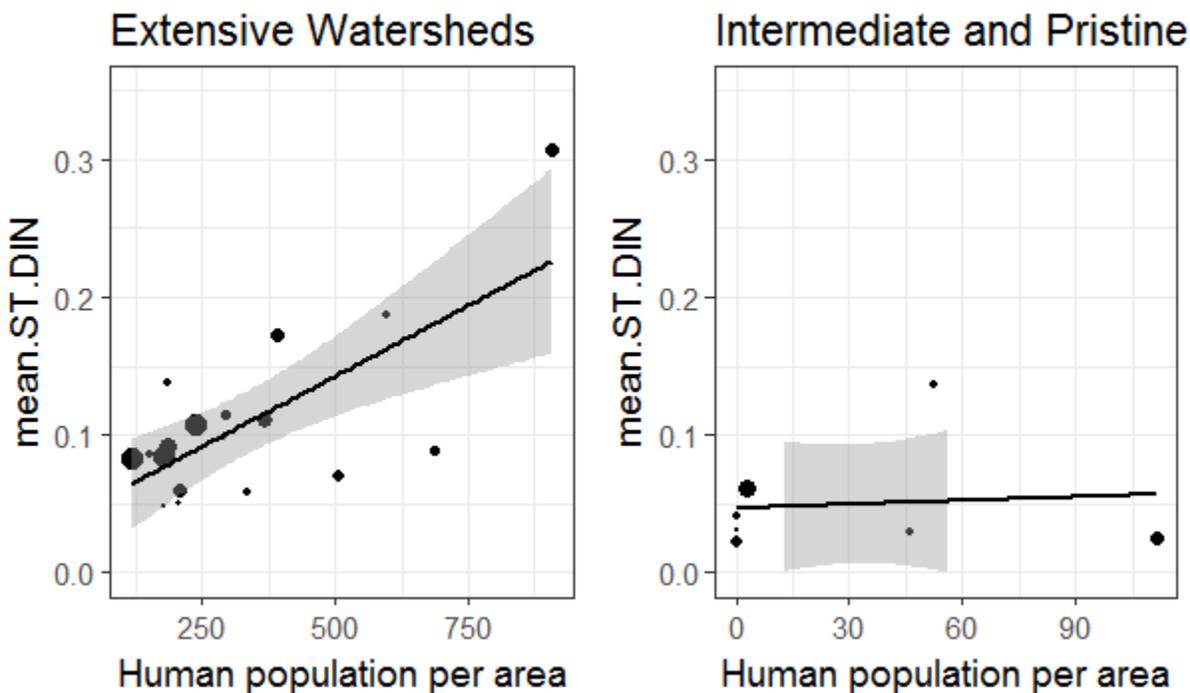
Figure 1. Mean stream DIN concentrations across extensive and pristine watersheds showing the significant relationship between population per area and DIN

that is evident only in extensive watersheds, while in intermediate and pristine watersheds DIN concentrations are low. Final project results will be available December 2017.

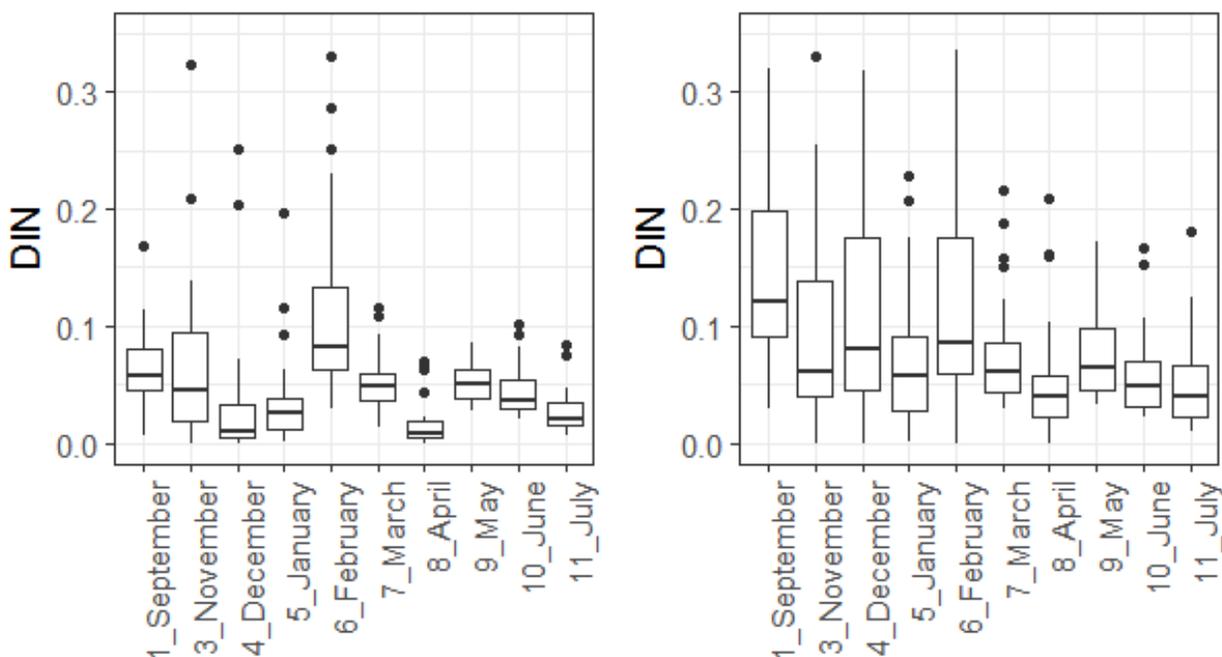
Figure 2. DIN concentrations Reef Flat (left panel) and Stream (right panel) over 10-months of sampling across 26 watersheds around Tutuila

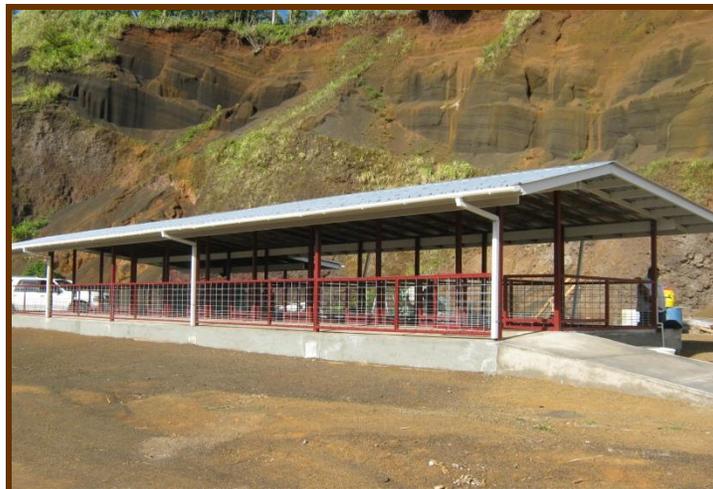
Initial operations of the different designs showed that the dry litter system is the most environmentally and financially beneficial design, and is preferred by nearly all the local farmers. The main advantage of the dry litter system is its use of wood chips as a bedding material that provides the carbon source for the composting process with the end result yielding a value added product, compost that can be sold. Once the demonstration project was in place, the local USDA-NRCS office was able to qualify existing piggery owners for EQUIP funded dry litter piggeries. To date 77 dry litter piggeries have been funded with an average cost of \$16,000 to \$40,000. It was anticipated that 15 to 12 dry litter piggeries per year will be funded through the EQUIP program. Most farmers build AS-EPA's standard 4-6 pen dry litter design but in FY13 two larger 10 pen dry litter systems (example pictured below) were constructed in Fagamalo and Leone.

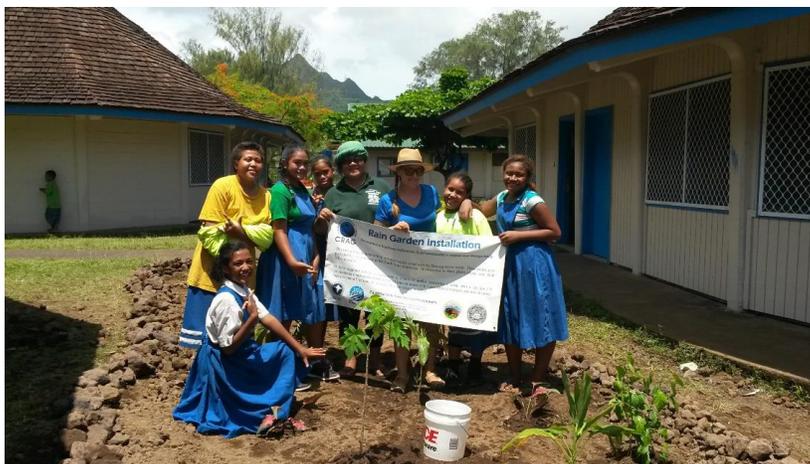
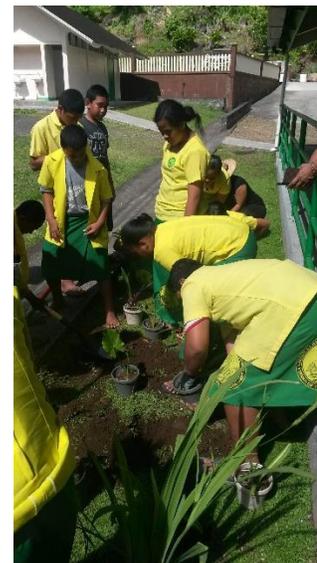
**Rain garden installation at Manulele Elementary School**

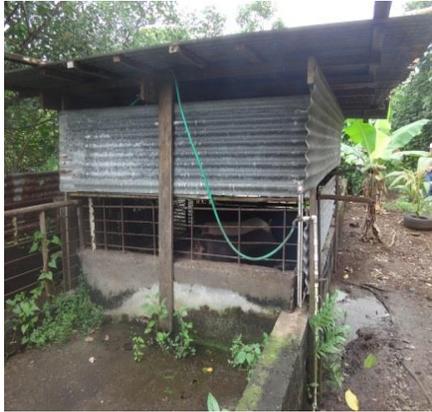
NPS-Piggery runoff into Leone Mangrove
