**American Samoa Environmental Protection Agency**

**Watershed Management and Protection Program**

**FY18 Annual Report**

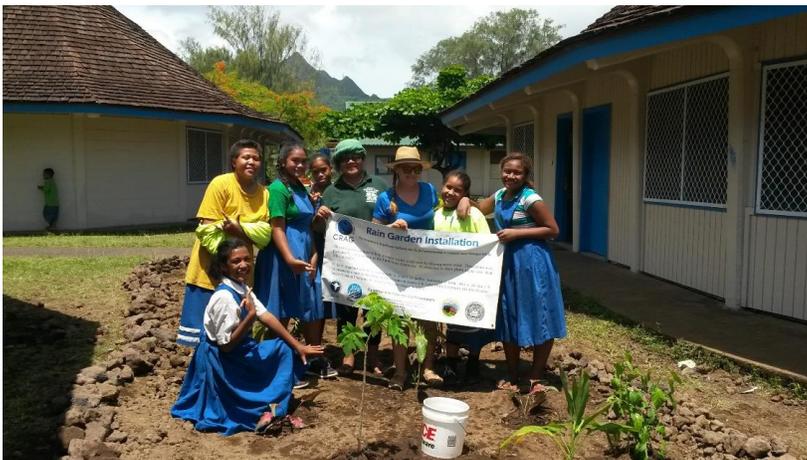
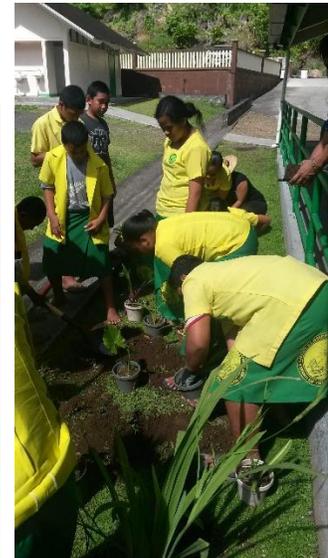
### Rain garden installation at Manulele Elementary School

In FY18, two school outreach events were conducted to increase awareness of stormwater management, rain garden installation and maintenance, and how these concepts tie into coral reef ecosystems. Both groups were briefed on how to design their own rain gardens and identify areas where rain gardens would be best suitable. Installation guides and rack cards were handed out at both events. Two youth groups (Maoputasi Coalition and Leone HS Green Club) were given tools to continue rain garden installation around the island. These groups have been involved in rain garden installation and have taken interest working closely with CRAG to install more rain gardens around their communities. MOUs were signed by both groups with a follow up report due every six months. CRAG hopes to continue working with community groups to increase capacity of rain garden installation around the island.

July during this summer camp. Students at Manulele Elementary were given a lesson on American Samoa's watersheds and its stormwater issues before a ~480 sq. ft. rain garden was installed on the campus by roughly 50 level 7 students. ASCC's Land Grant students and staff received a two-hour seminar on watersheds, stormwater, and raingardens. This was shortly followed by a collaborative design and installation of a stormwater ditch retrofit in the form of a ~1300 sqft rain garden. The collaboration with ASCC helped to build the capacity of the college to educate others about and proliferate stormwater best management practices.

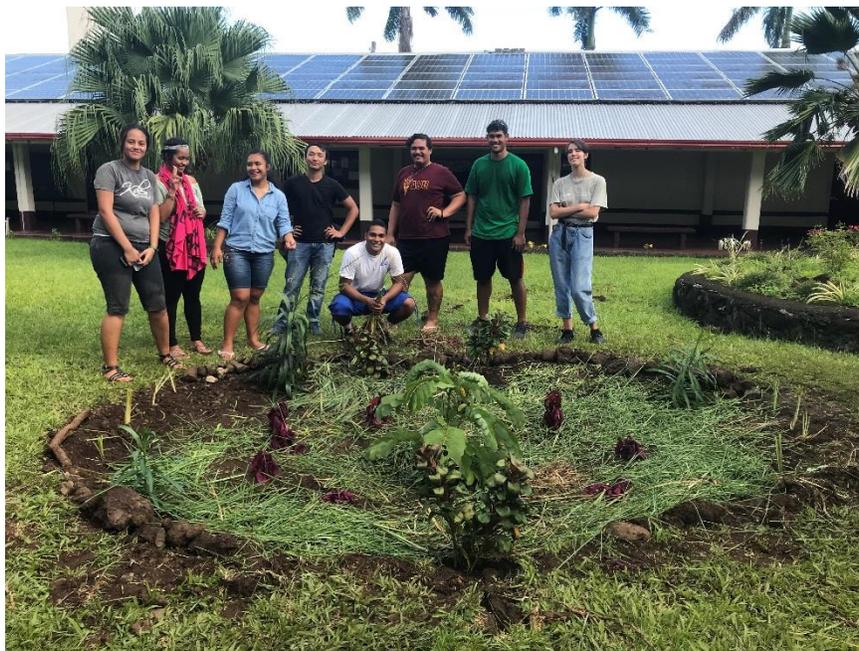
Photo: ASCC Marine Science students and CRAG intern (far right) standing next a rain garden they installed on campus. PC: Meagan Curtis 2018

of ~2,000sq.ft. It is one of the two rain gardens in the main quad of the campus that help drain pooling rain water that floods the area. This rain garden makes the seventh rain garden installed in the local priority watershed of Nu'uuli. Tools and equipment were provided and funded by DOI and NFWF-CRCP. Land Grant donated plants and assisted with installation. Maintenance of existing rain gardens have been a priority during FY18. A CRAG staff and intern have been assisting in replacing mulch and plants at some rain gardens that have not been maintained. Educational signs have also been installed to recognize eight rain gardens and increase awareness of rain garden importance.

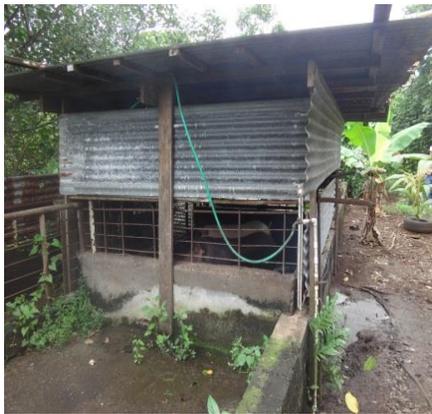
NPS-Piggery runoff into Leone Mangrove

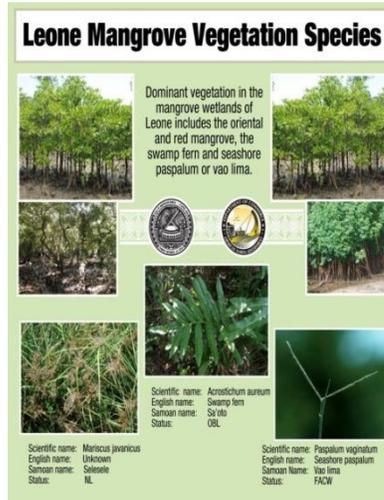
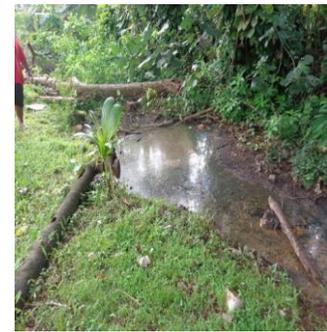
NPS-Sink/Shower runoff
